# **GREEN SHEET**

## **SACRAMENTO FIRE DEPARTMENT**

### **Informational Summary Report of Serious SFD Injuries, Illnesses, Accidents and Near-Miss Incidents Residential Structure Fire**

**Thermal injuries to 3 Firefighters**

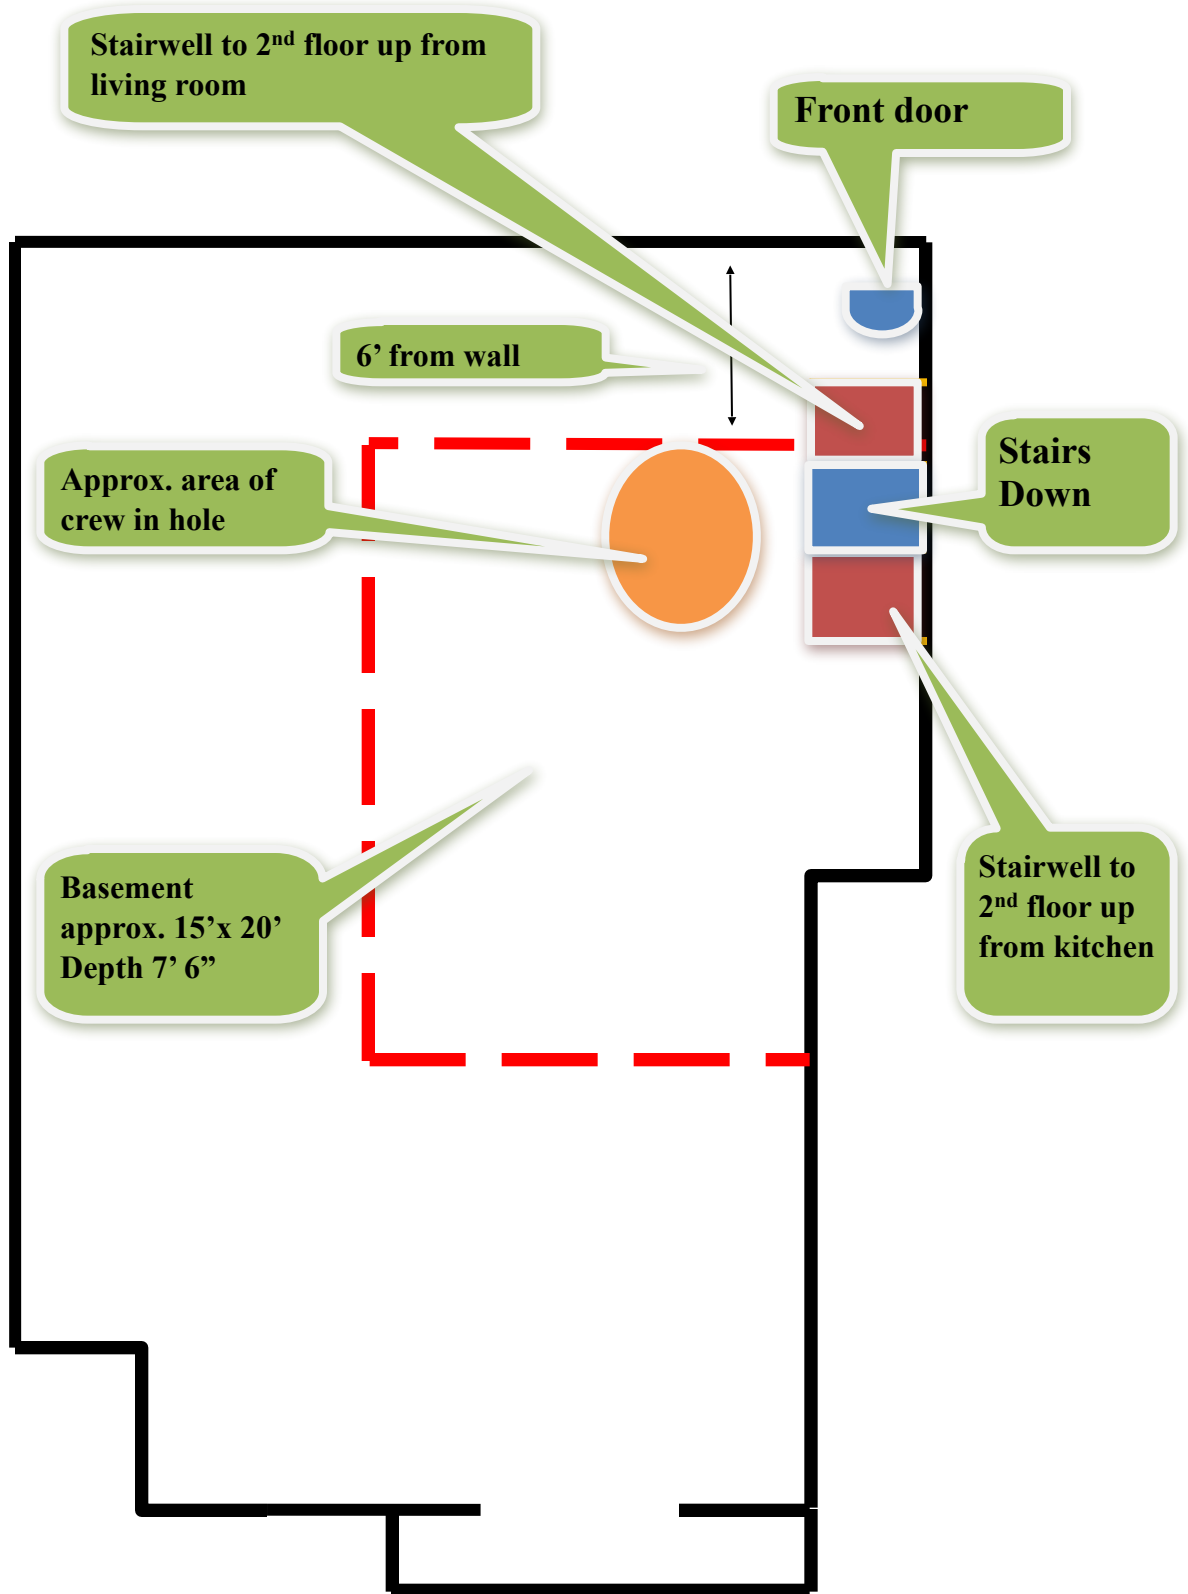
“A” side Edge  
of basement
