SAFETY ALERT

Subject: **Lucard Incident – Firefighter Through Garage Floor**

LUCARD INCIDENT

Incident # 12-36623

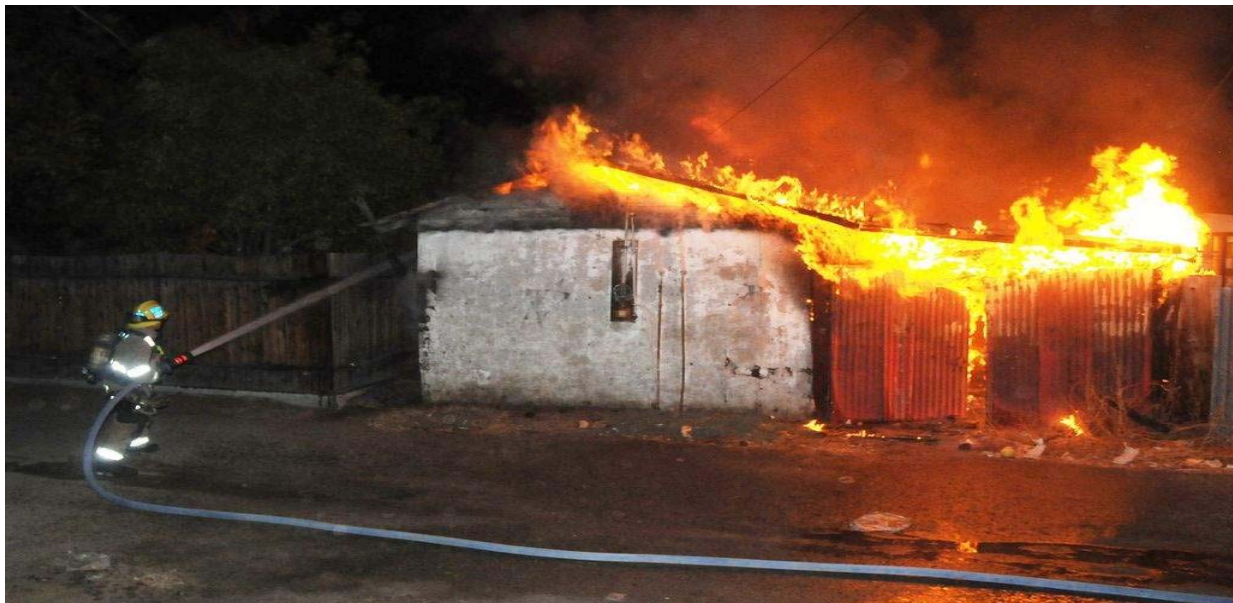
Alley Exterior View E-21 Fire Attack

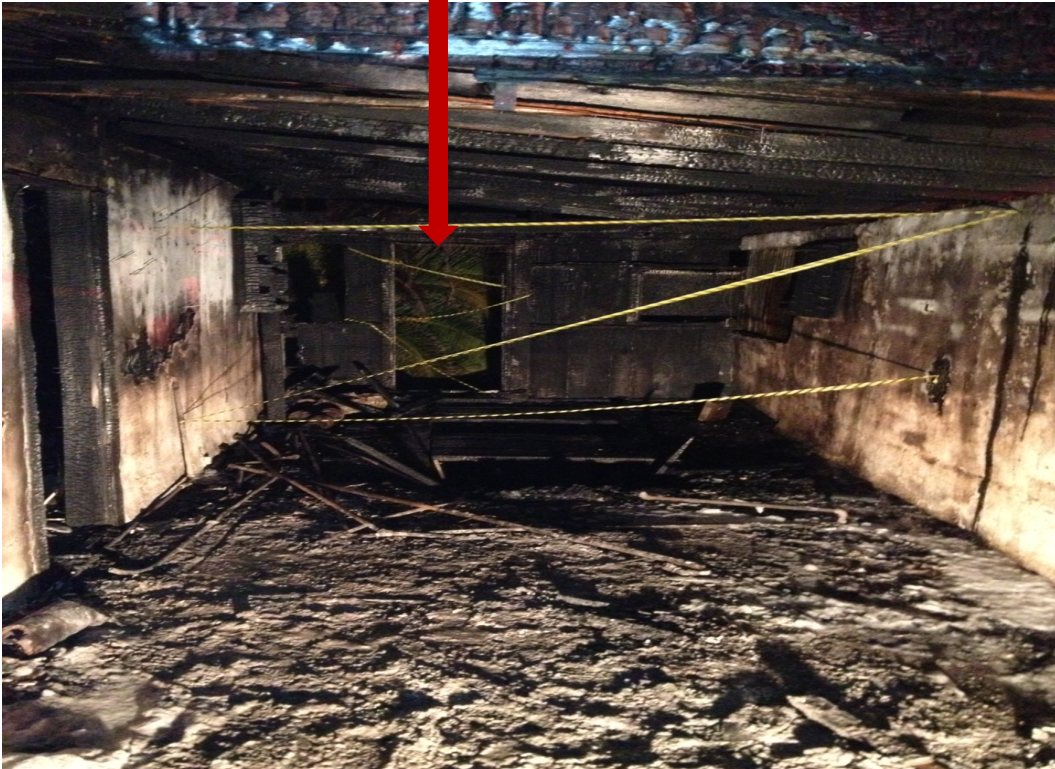
INTERIOR VIEW OF DOOR INJURED F/F ENTERED

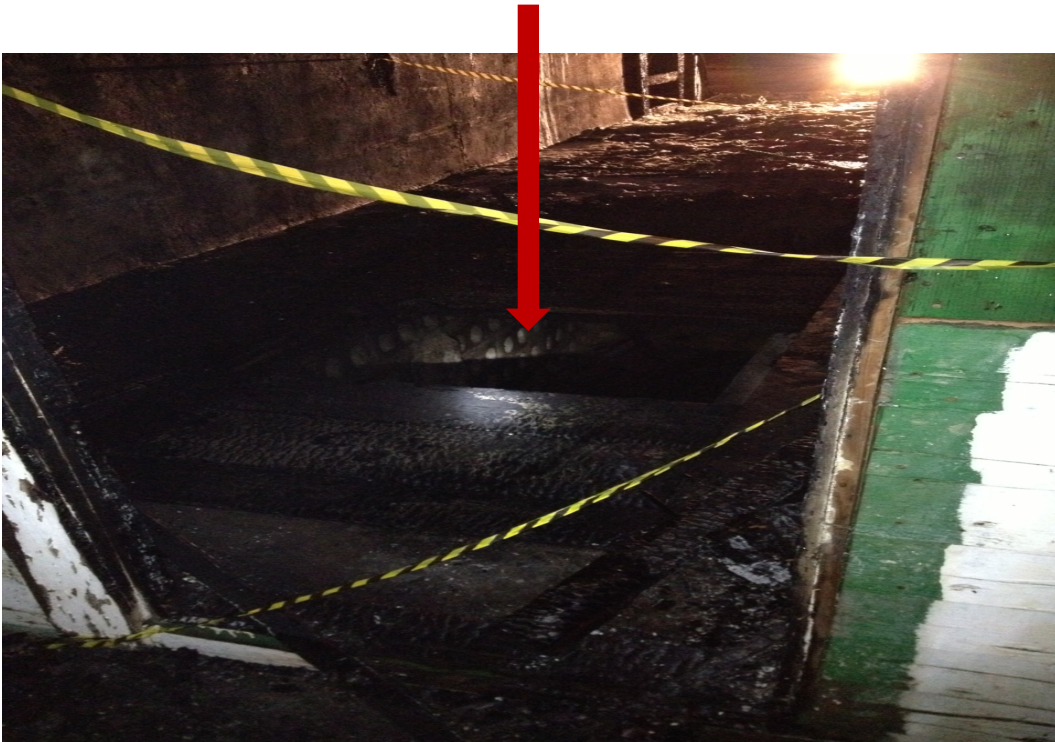
At approximately 1815 hrs. on Tuesday, November 20th 2012 a firefighter fell into a hole in the floor of a garage, receiving moderate injuries to the upper left quadrant of the torso.

Dark, smoky conditions combined with the wearing of an SCBA mask contributed to the firefighter not being able to see the hole in the floor. When making entry into structure fires there are always unknowns that present possible injury or life hazards to firefighters. If you cannot see where you are walking, there are several ways to minimize the chances of falls and potential injuries.

VIEW FROM DOOR F/F ENTERED AND AUTO SERVICE PIT

1. Sweep the area in front of you with a tool to detect obstacles
2. Sound the floor with a tool to insure its integrity
3. Use your flashlights and/or set up auxiliary lighting sources
4. Address ventilation to increase interior visibility
