GREEN SHEET

Informational Summary Report of Serious CAL FIRE Injuries, Illnesses, Accidents and Near-Miss Incidents

Vehicle Accident MEU Engine 1169 and Engine 1151 Minor and Moderate Engine Damage

CA-MEU-005340

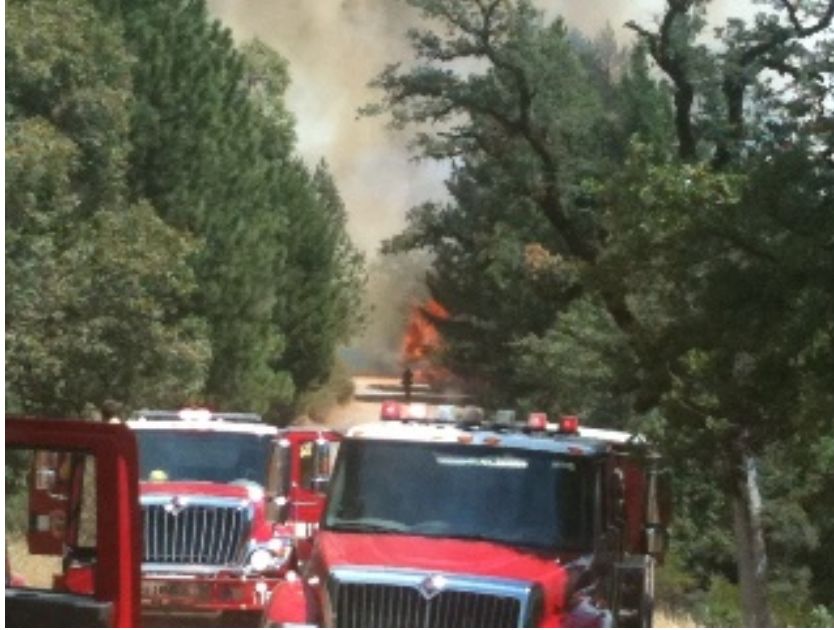
Image taken by Firefighter after collision and as flare-up has subsided.
Viewing east from collision location.

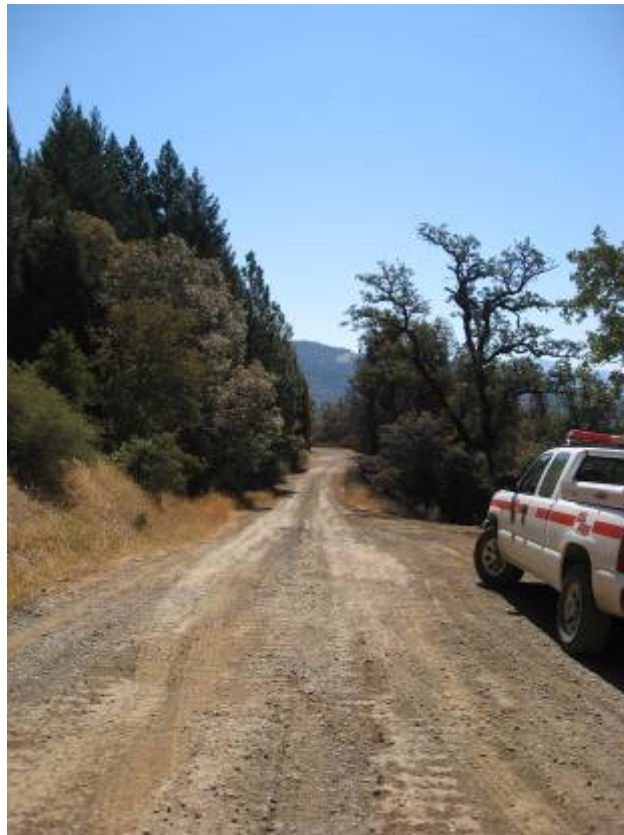
Similar view during post incident accident review.

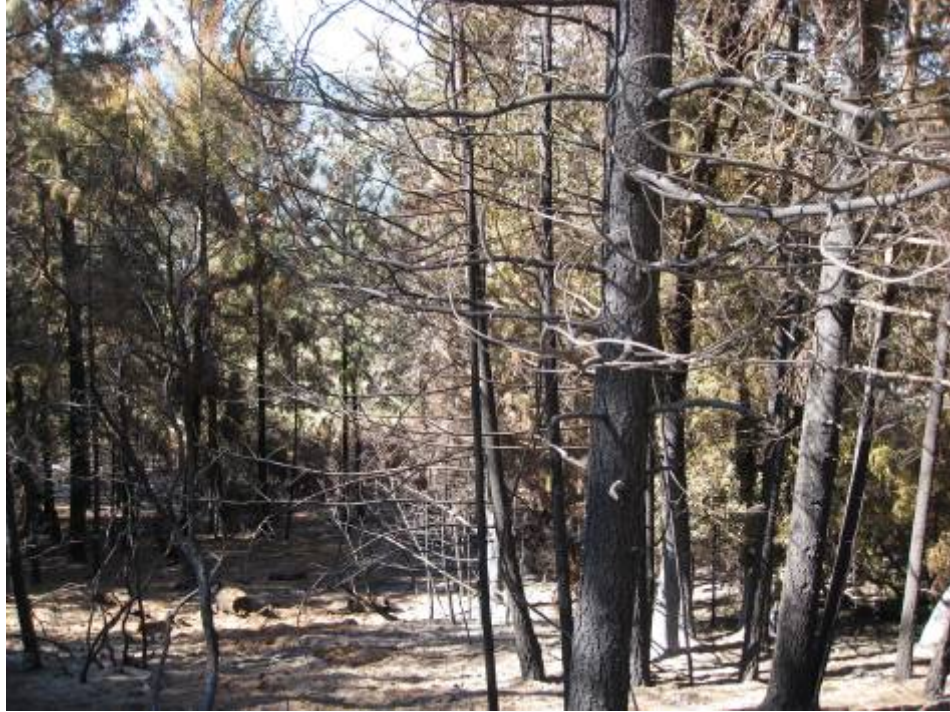
North portion of the timber patch receiving the most intense heat.
Viewing south from Blands Cove Road.

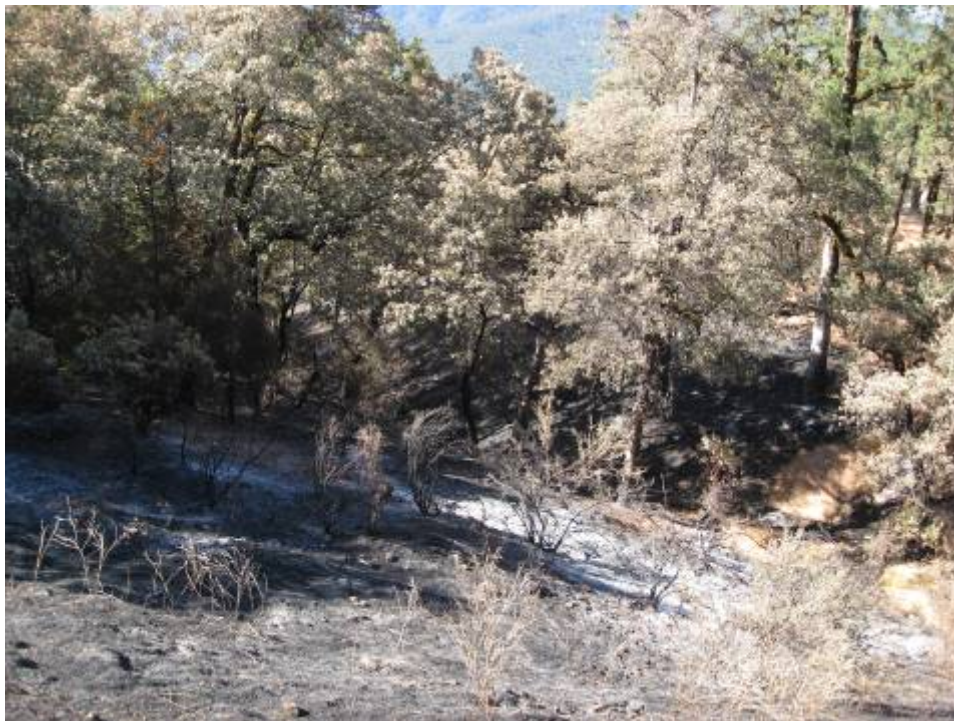
Blands Cove Road (USDA – Forest Service Road 24N21) is a standard seasonal 20-foot wide dirt and rock-surfaced road. In the area of the accident, the road is approximately at mid-slope and trends east-west. The topography below the road is broken and, immediately beneath the flare-up and accident location, the slopes range from 40% to 50%. Interpretation of burn patterns and fire direction macro-indicators post-incident are consistent with the high heat concentration and flare-up which occurred in the patch of timber. Below the flare-up site, there is a distinct seasonal watercourse channel/swale which acted as a chimney. This feature is identified on the USGS topographic map (see attached topographic map insets on schematics). The channel very likely influenced the fire behavior that lead to the flare-up by concentrating heat and funneling winds towards the brush and timber.

The draw just west of the flare-up. Viewing south from Blands Cove Road.

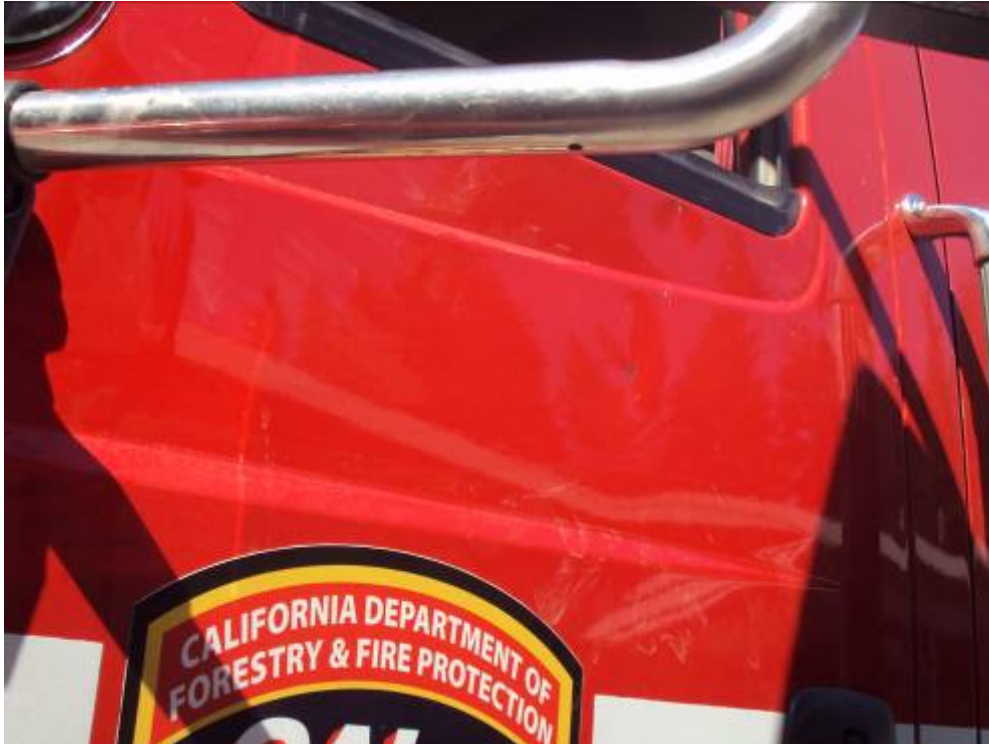
There were no reported injuries. Engine 1169 (Model 34) received minor damage to the driver side door (a small dent) and a dent on the upper rear compartment. Engine 1151 (Model 34) received moderate damage to the engine's right rear corner. Engine 1169 was evaluated and repaired. Engine 1151 was evaluated to determine needed repairs.

Damage to Engine 1169 – Driver's door.

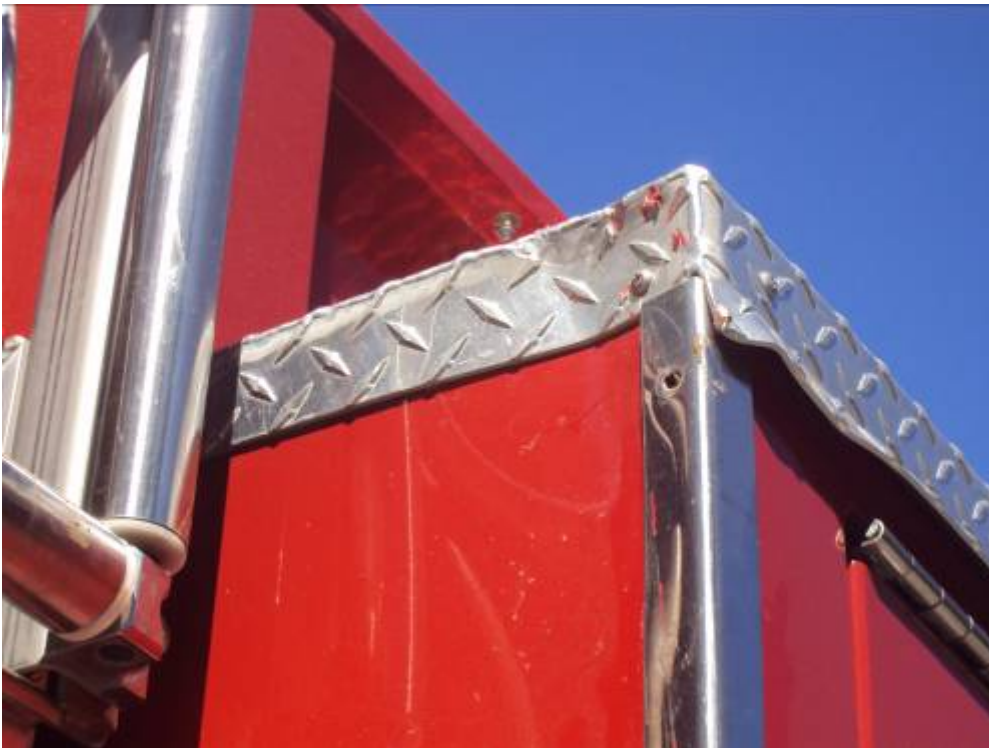
Damage to Engine 1169 – Driver's side compartment.

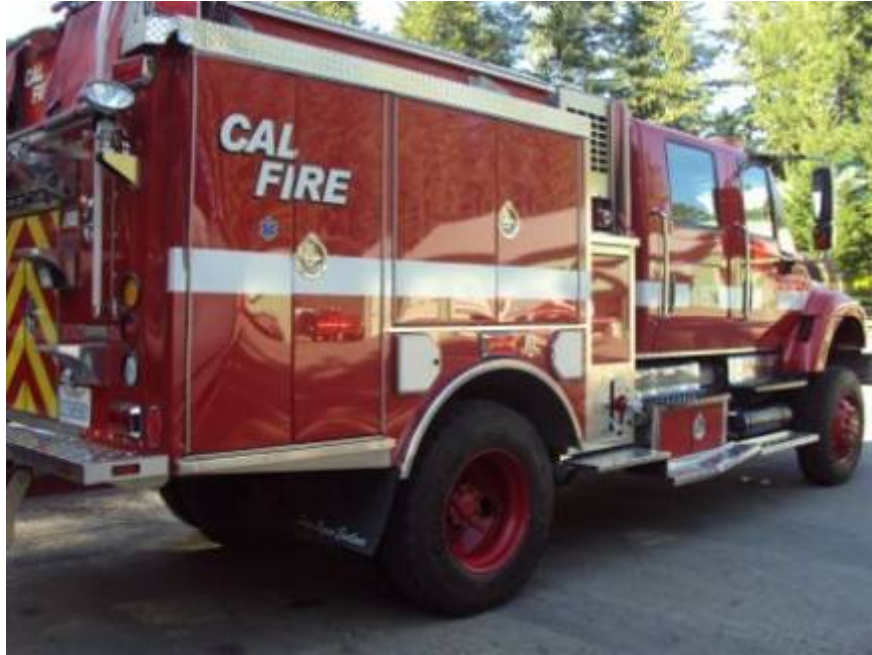
Damage to Engine 1151 – right rear corner and side step damaged.
