# **GREEN SHEET**

### **Informational Summary Report of Serious CAL FIRE Injuries, Illnesses, Accidents and Near-Miss Incidents**

#### **Structure Fire with Explosion – Near Miss**

**Monte Incident  
12-CA-RRU-041726**

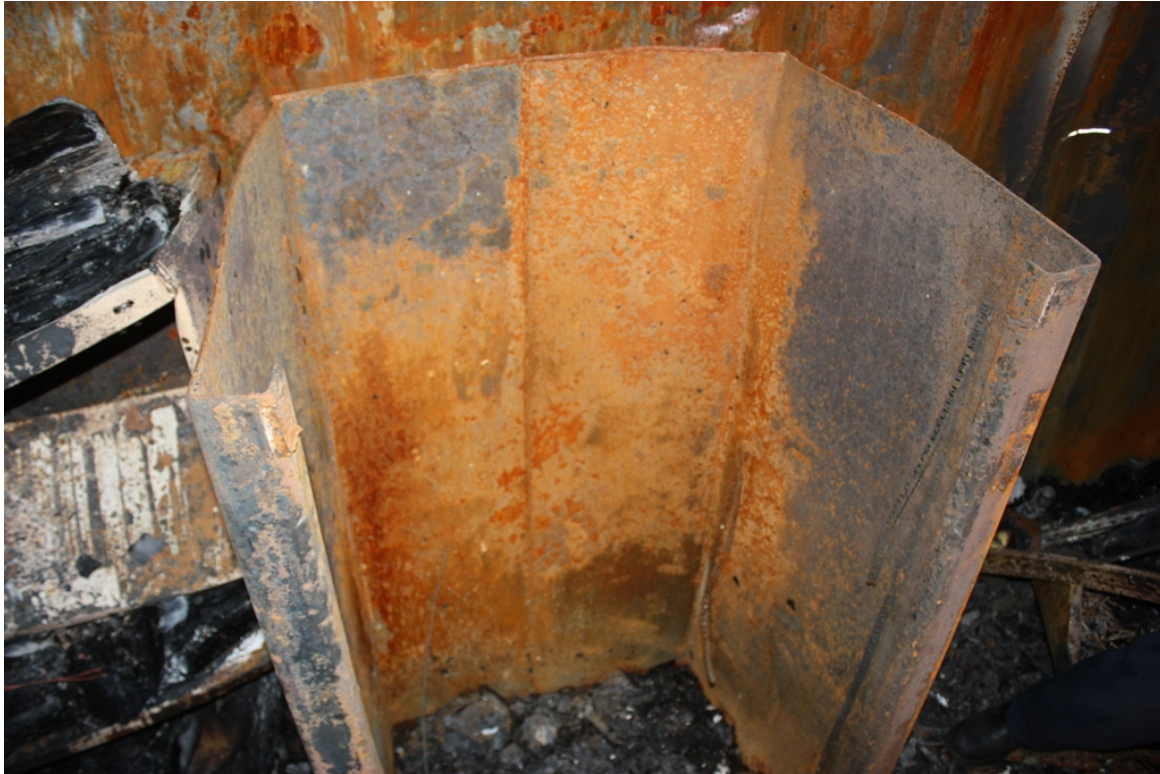
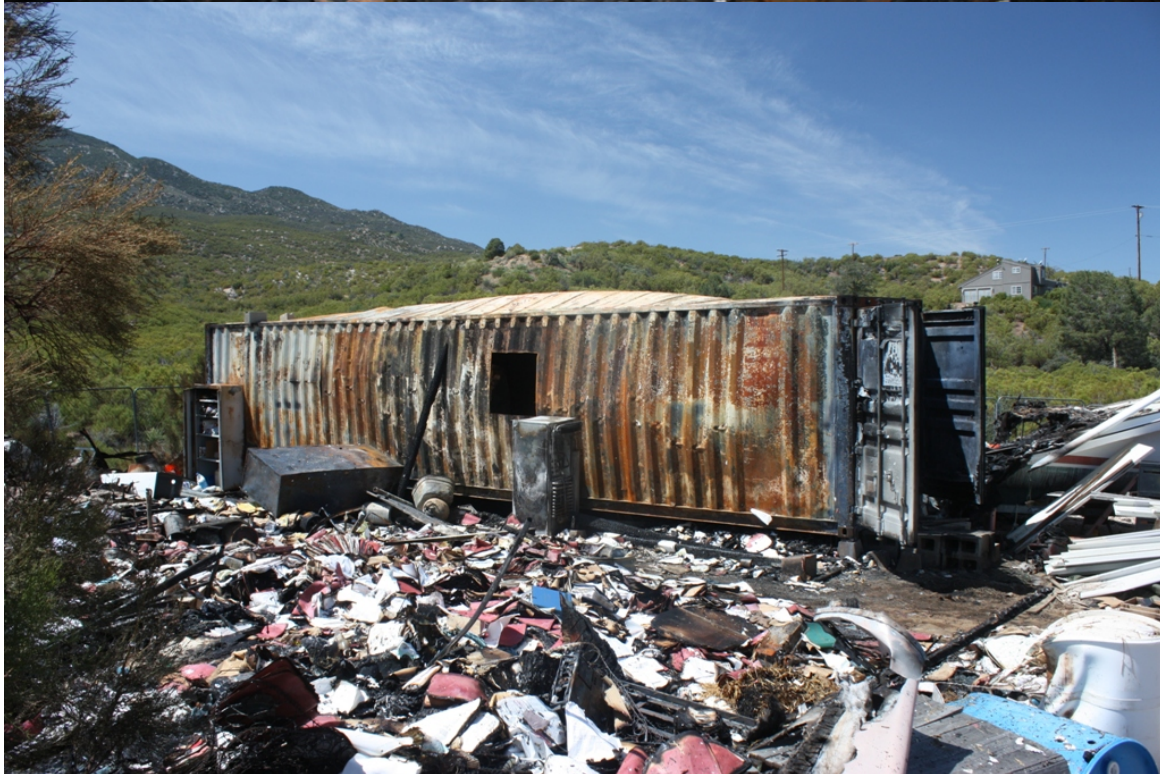
At approximately 1640 hours, crews once again noted a significant amount of ammunition begin to explode. The property owner returned to the scene and notified the incident commander that there was ammunition and reloading equipment in the shipping container which also included black powder and smokeless gun powder. The Incident Commander made the decision to pull fire crews further back and to reset the hose lines. During the repositioning of the hose lines, a violent explosion occurred inside the shipping container. After the explosion, a Fire Captain was located on the ground near a chain link fence. On scene personnel immediately assisted the fire captain and quickly removed him to a safe area due to possible secondary explosions. The Incident Commander which was now the Battalion Chief immediately completed an accountability check of all incident personnel. Additionally, an ambulance, the Hazardous Materials Unit and the Riverside County Sheriff's Department Hazardous Device Team (bomb squad) were requested by the Incident Commander. It was later identified that a large gun safe containing weapons, ammunition and gun powder had a catastrophic failure which blew off the front door and top.
