# **GREEN SHEET**

### **Informational Summary Report of Serious CAL FIRE Injuries, Illnesses, Accidents and Near-Miss Incidents**

#### **Firefighter Struck by Exploding LPG Lantern**

**12-CA-RRU-103004**

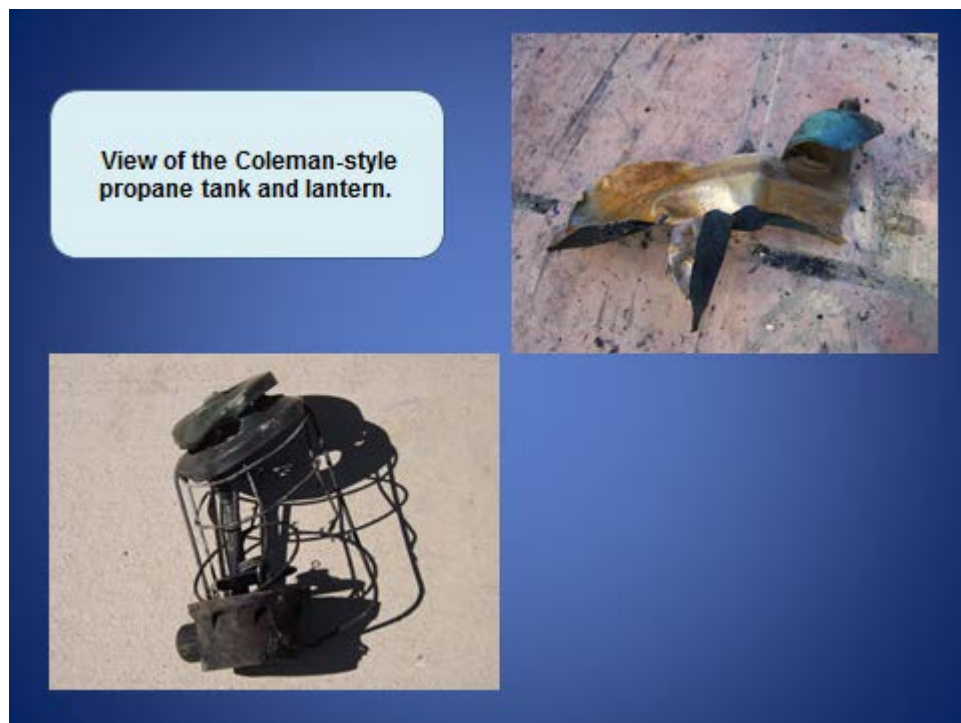
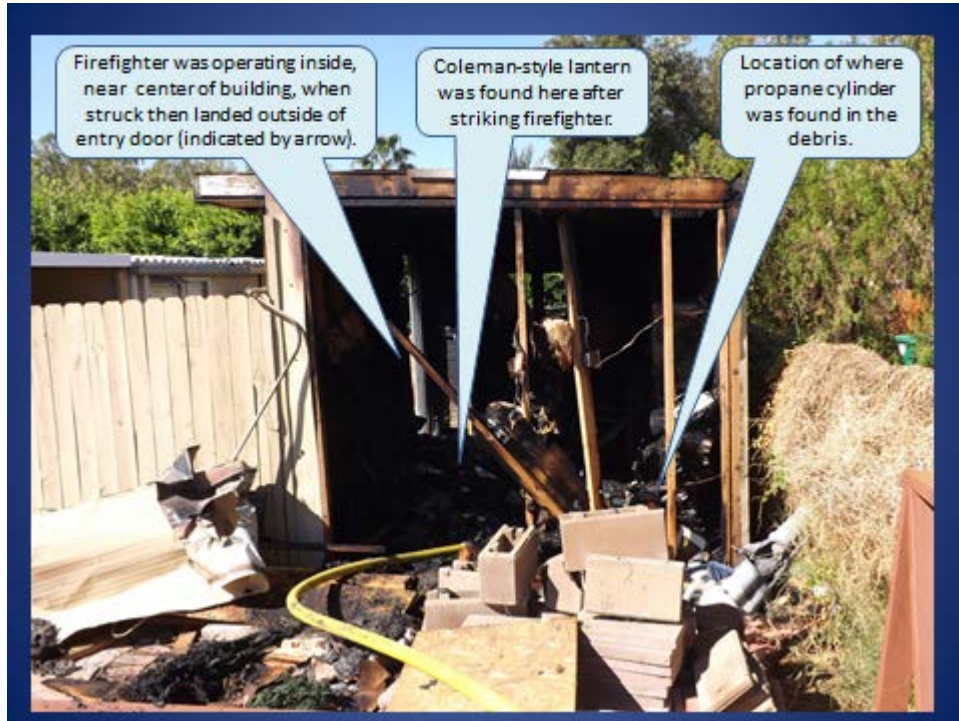
After approximately 5-6 minutes of fire attack, a large explosion occurred inside the shed accompanied by a small flash ball of fire and a blast wave of pressurized air. During this explosion, the Firefighter who was on the nozzle was struck by an object, which was later identified as a small camping lantern, in the chest and thrown out of the shed to the ground by the blast. The Firefighter was immediately assisted to his feet and escorted to Medic 55 by scene personnel.
