Informational Summary Report of Serious CAL FIRE Injuries, Illnesses, Accidents and Near-Miss Incidents

Structure Fire

Firefighter Head Injury

November 13, 2012

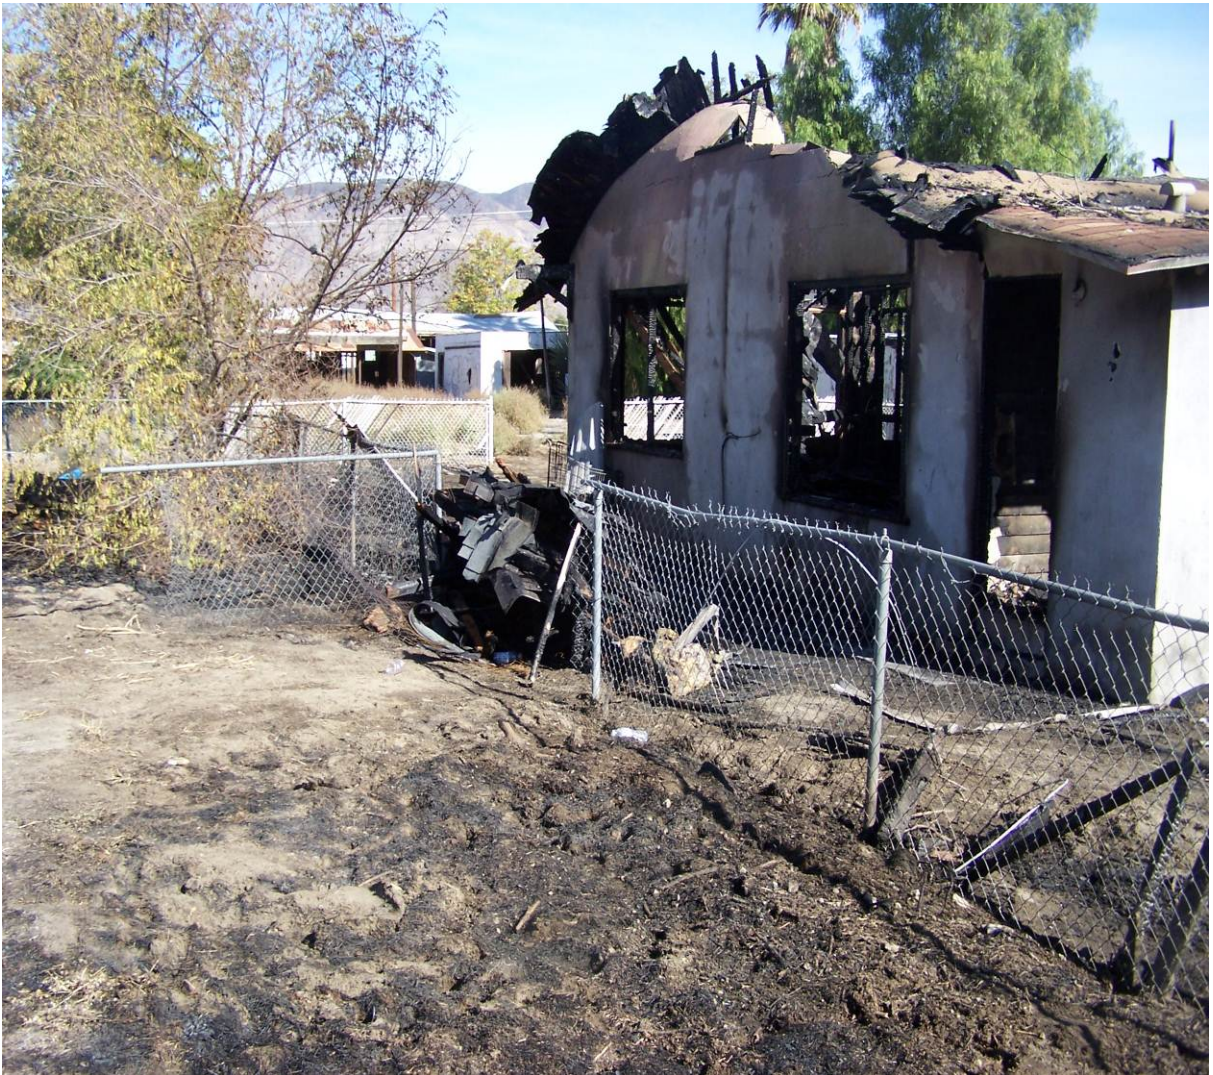
After the 5-7 minutes of fire attack, a structural collapse of the roof in the area where the attack team was operating occurred. The roof collapsed inward, with the structural failure located in the middle of the room, which caused the exterior roof eaves to violently be forced in an upward direction. The rapid upward movement of the roof eaves caused the roof eave fascia board to become dislodged and fall. Due to the close proximity of the attack team to the structure during their fire attack efforts, the fascia board fell onto the three members of the attack team. As the fascia board was falling, the Firefighter from E-72 instinctively raised a hand in an effort to block the falling fascia board. The falling fascia board hit the Firefighter's hand and the board broke. While this blocking action lessened the impact of the falling fascia board, the fascia board still hit all three members of the attack team. The Firefighter Paramedic who was on the nozzle was hit in the helmet and shoulder by the falling fascia board. This impact dazed the Firefighter Paramedic to the point the firefighter fell to the knees, leaned against and slid down the exterior wall of the still burning structure.

- Delta (D) side of structure where fire attack was initiated.
- Cut in fence is where access was made to fire property.
- Area between two bay windows is where fire attack personnel were standing when collapse occurred.

- Establish a collapse zone during exterior defensive firefighting.
 - When conducting a defensive exterior attack on a structure that is involved in an advanced fire condition, a collapse zone must also be established. The size of this collapse zone will vary based on building construction, fire conditions and fire load and type. The general rule of establishing a safe collapse zone shall be a distance away from the structure equal to 1.0 to 1.5 times the height of the structure. This collapse zone must be maintained for personnel safety until a structural risk assessment has been performed by qualified incident command staff.

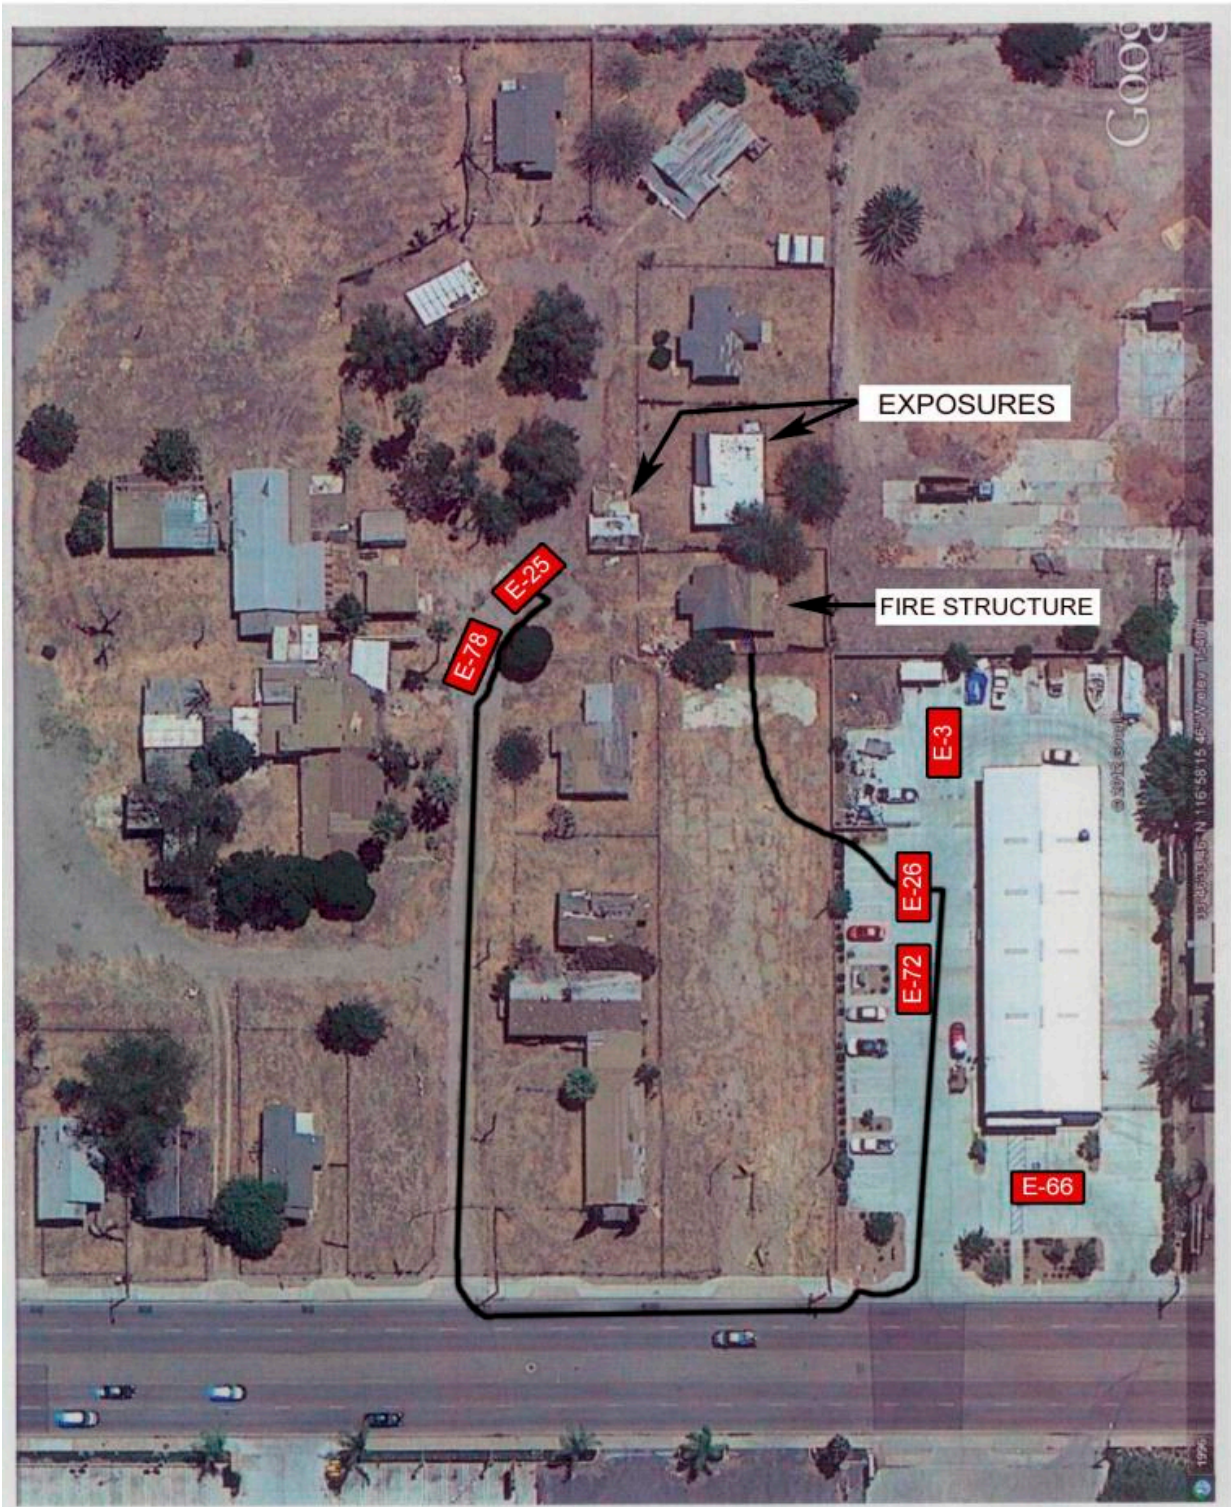
- Large paved road is State Street.
- Small access lane that Engines 25 and 78 are located is Kuhns Drive.
- Hose lines are representative at the time of collapse.
