Informational Summary Report of Serious CAL FIRE Injuries, Illnesses, Accidents and Near-Miss Incidents

Partial Building Collapse with Injuries

November 11, 2011

GLEN SIDE

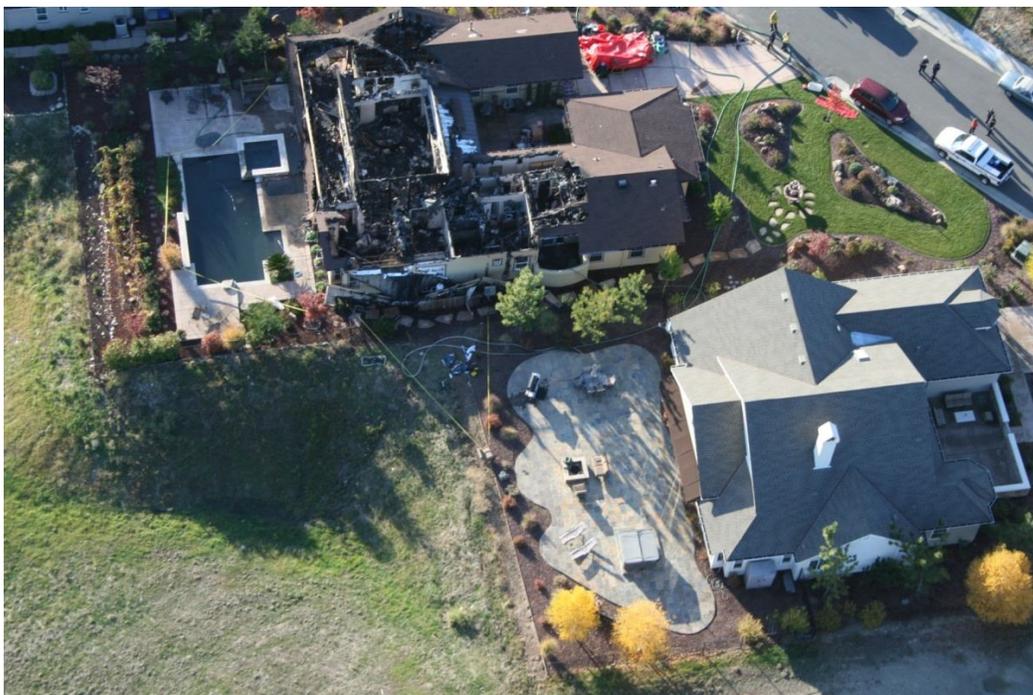
(Photo taken November 12, 2011)

At approximately 2349 hours, while performing an exterior attack, a CAL FIRE Captain sustained serious injuries due to a partial building collapse. The CAL FIRE Captain was struck by a portion of a wall and roof as it collapsed.

The first arriving CAL FIRE Captain and a CFPD Firefighter were working exterior operations in the area of the “B/C” corner. At approximately 2349 hours there was a partial building collapse near the “B/C” corner. The collapse struck the CAL FIRE Captain and CFPD Firefighter.

The collapse is best described as the eave and gable end truss from the “B/C” corner forward to the “A/B” corner. The length of the collapsed section was approximately 47’ in length. The collapsed section also included the stucco covering of the gable end truss that hinged from the area of the top plate and remained partially attached. The initial indications are that as the gable end truss failed, it swung from the hinge point and struck the CAL FIRE Captain and the CFPD Firefighter, knocking them both to the ground.
