GREEN SHEET

Informational Summary Report of Serious CAL FIRE Injuries, Illnesses, Accidents and Near Serious Accidents

Engine Burn Over

Pacheco Incident

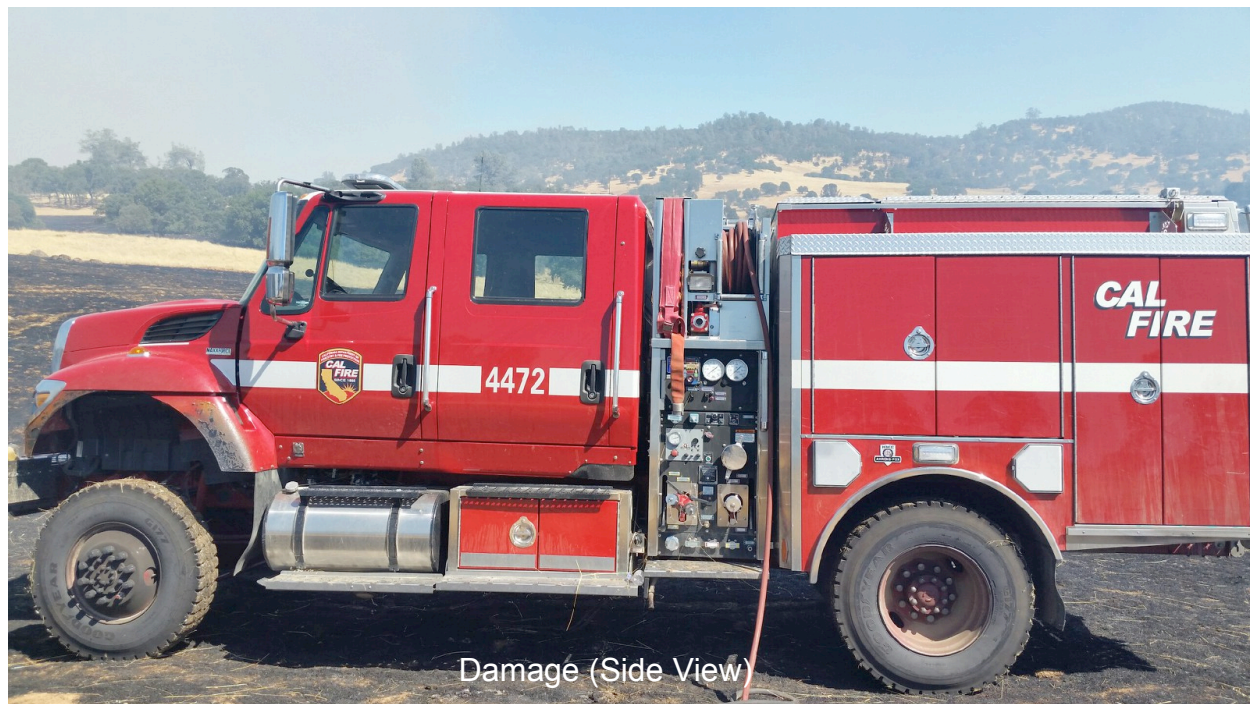
Flame impingement caused the airlines above the frame rails to burst. When the air pressure dropped below 60 psi, FC1 was unable to release the spring brake. FF2 ran back to E1. A helicopter dropped water around E1 while D1 constructed line around a portion of E1 to protect the crew. FC1 notified the Incident Commander that all personnel were accounted for and in a good location.

There were no injuries. E1 sustained heat damage to the tires, fenders, lens covers, air brake lines and pump panel.

Damage (Side View)

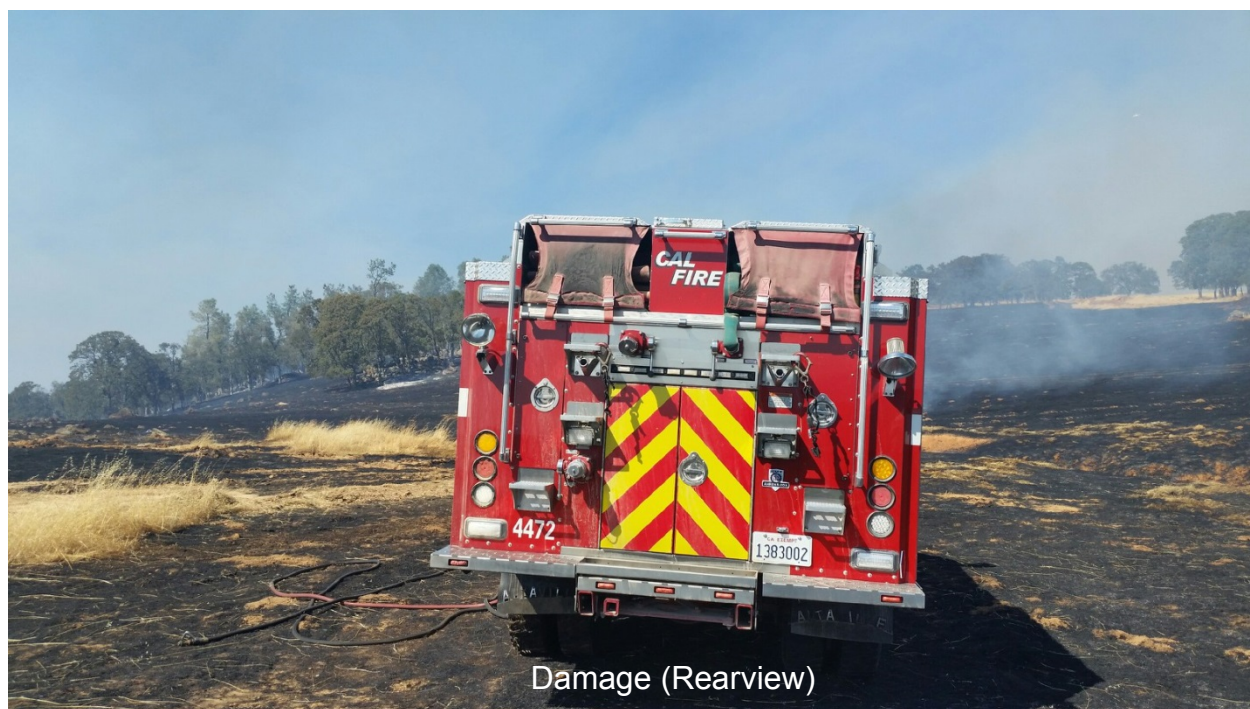
Damage (Rearview)
