Informational Summary Report of Serious CAL FIRE Injuries, Illnesses, Accidents and Near-Miss Incidents

Burnover/ Entrapment with Burn injuries

LODGE Fire Complex

14-CA-MEU-007575

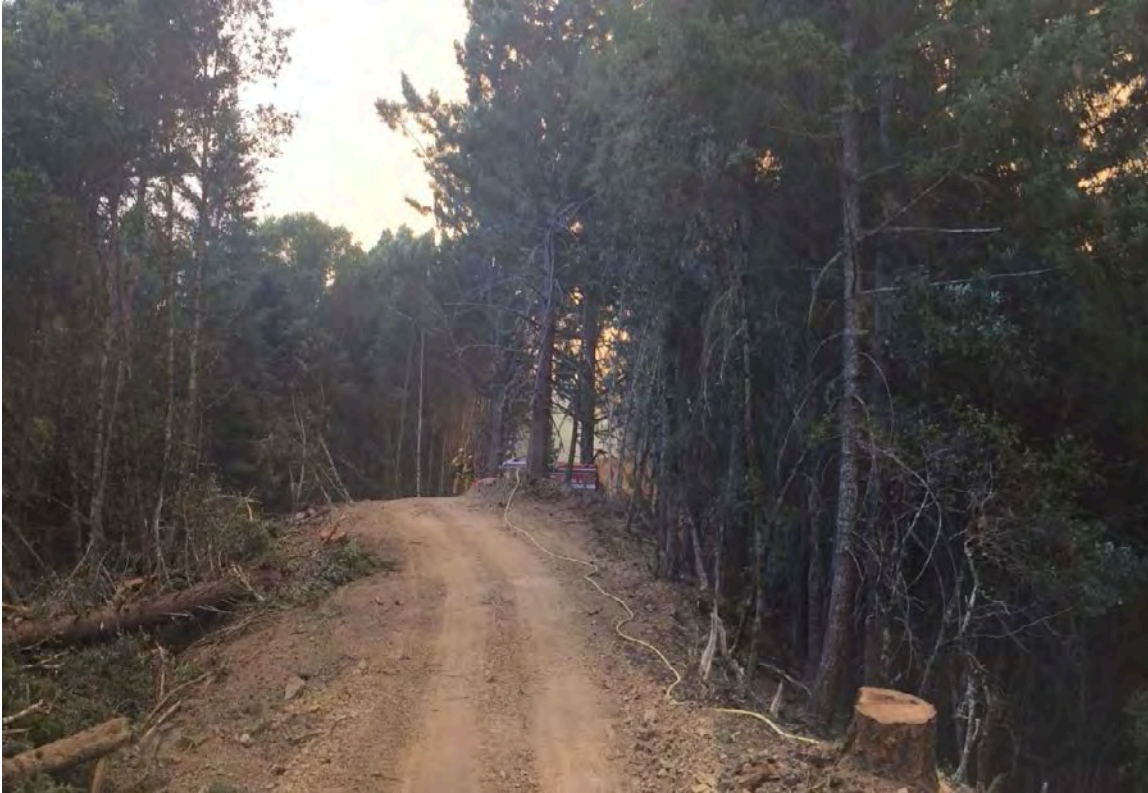
Drive in from DP 11 south towards the Division P/W break from E374 \approx 1826 hours

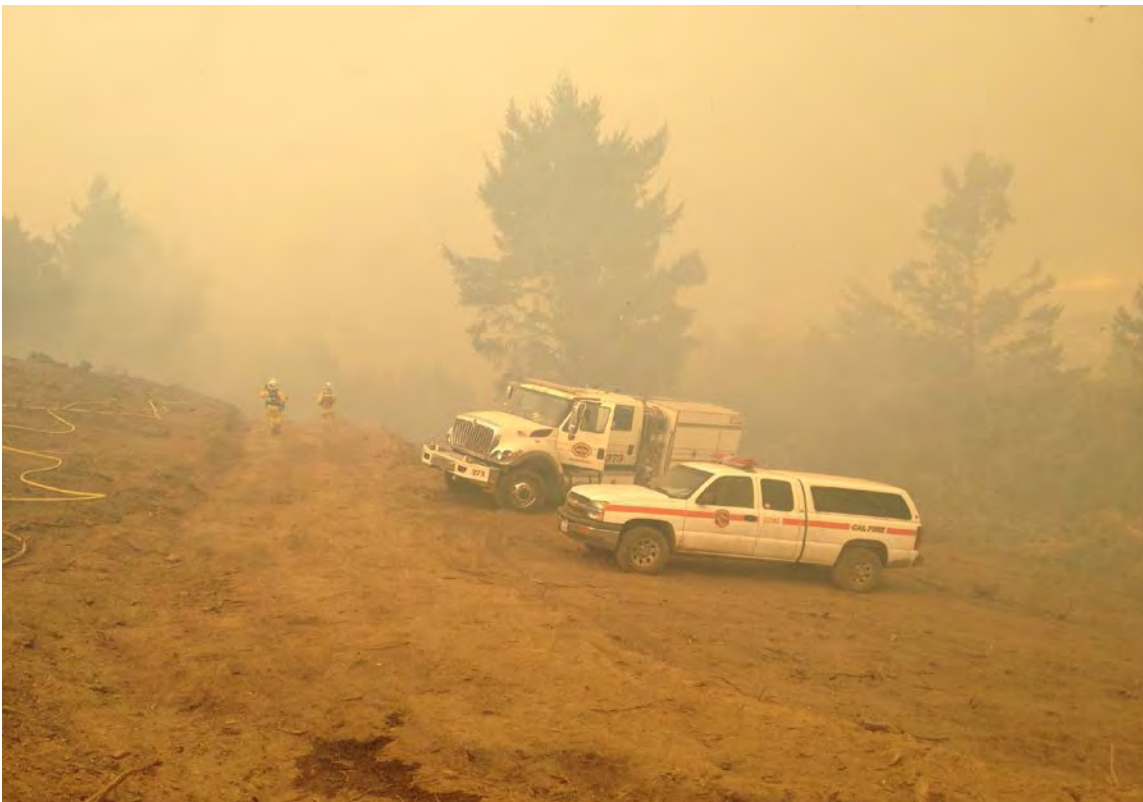
E373 and UT-1 looking north from ENG-1 at the Division P/W break \approx 1827 hours

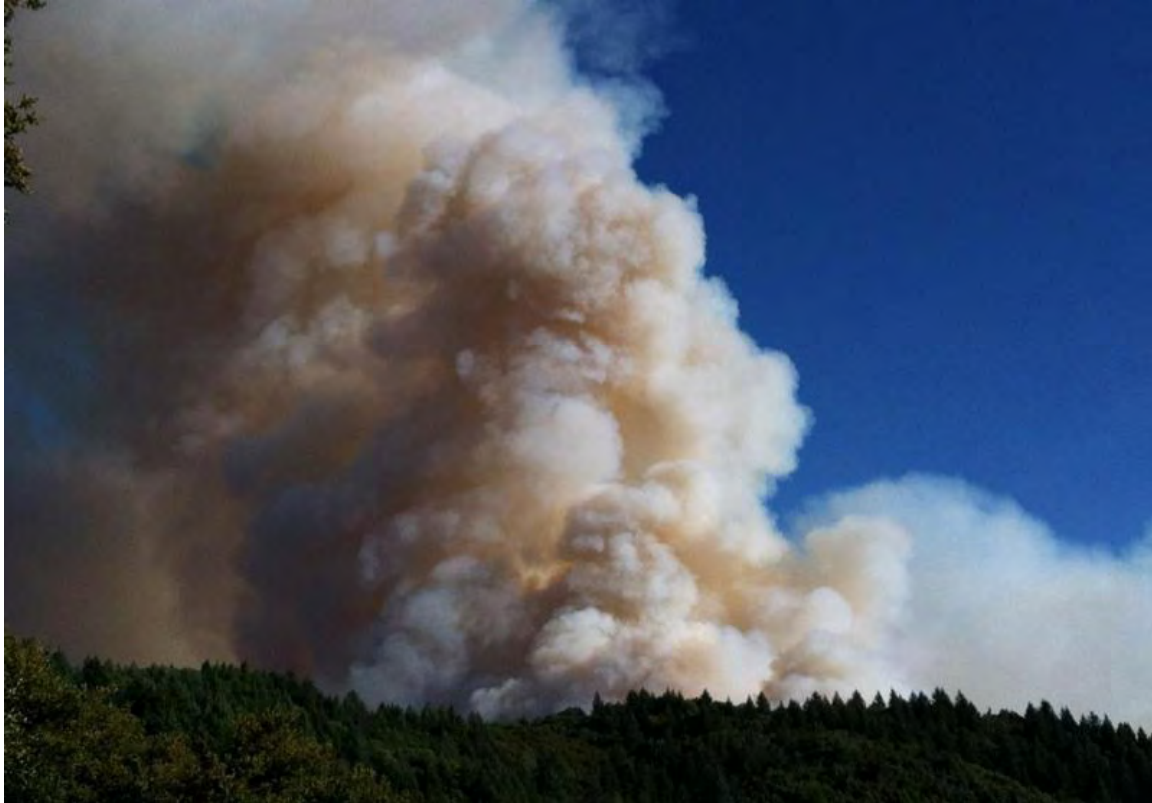
From DP11 south towards the Division P/W break and Ten Mile Peak \approx 1828 hours

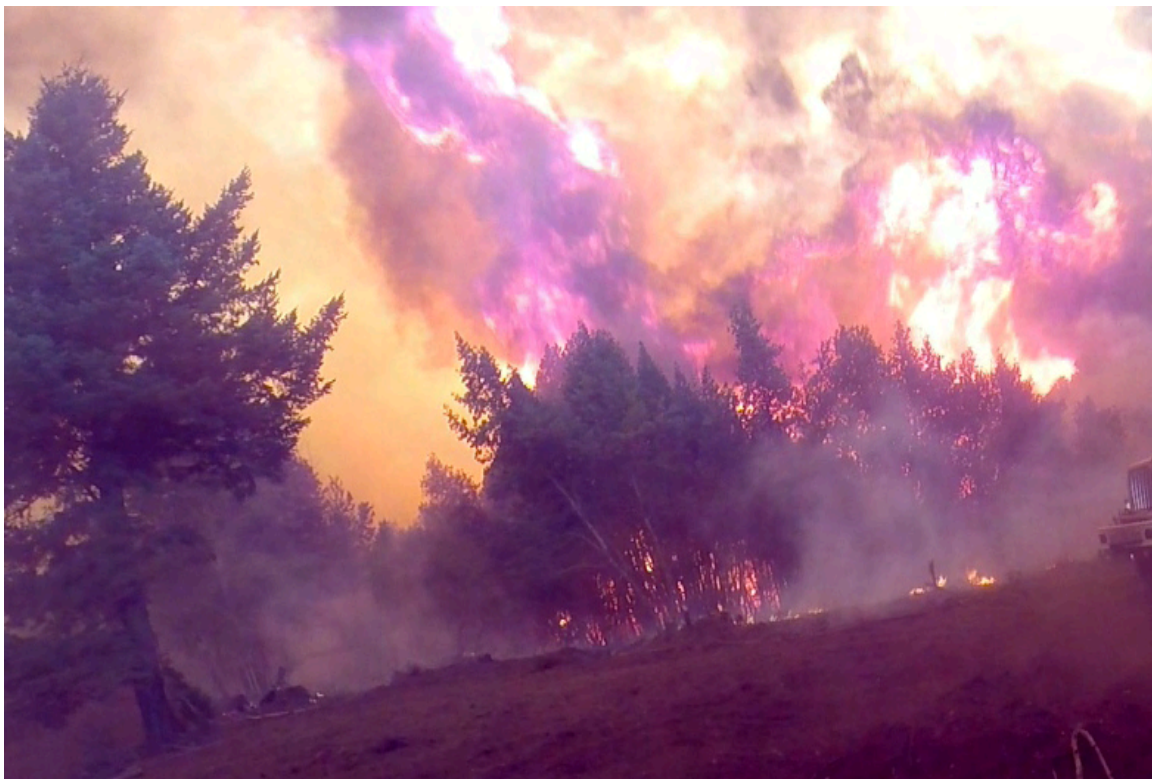
View from the bend in the road, west into the Hogshed Creek drainage \approx 1833 hours

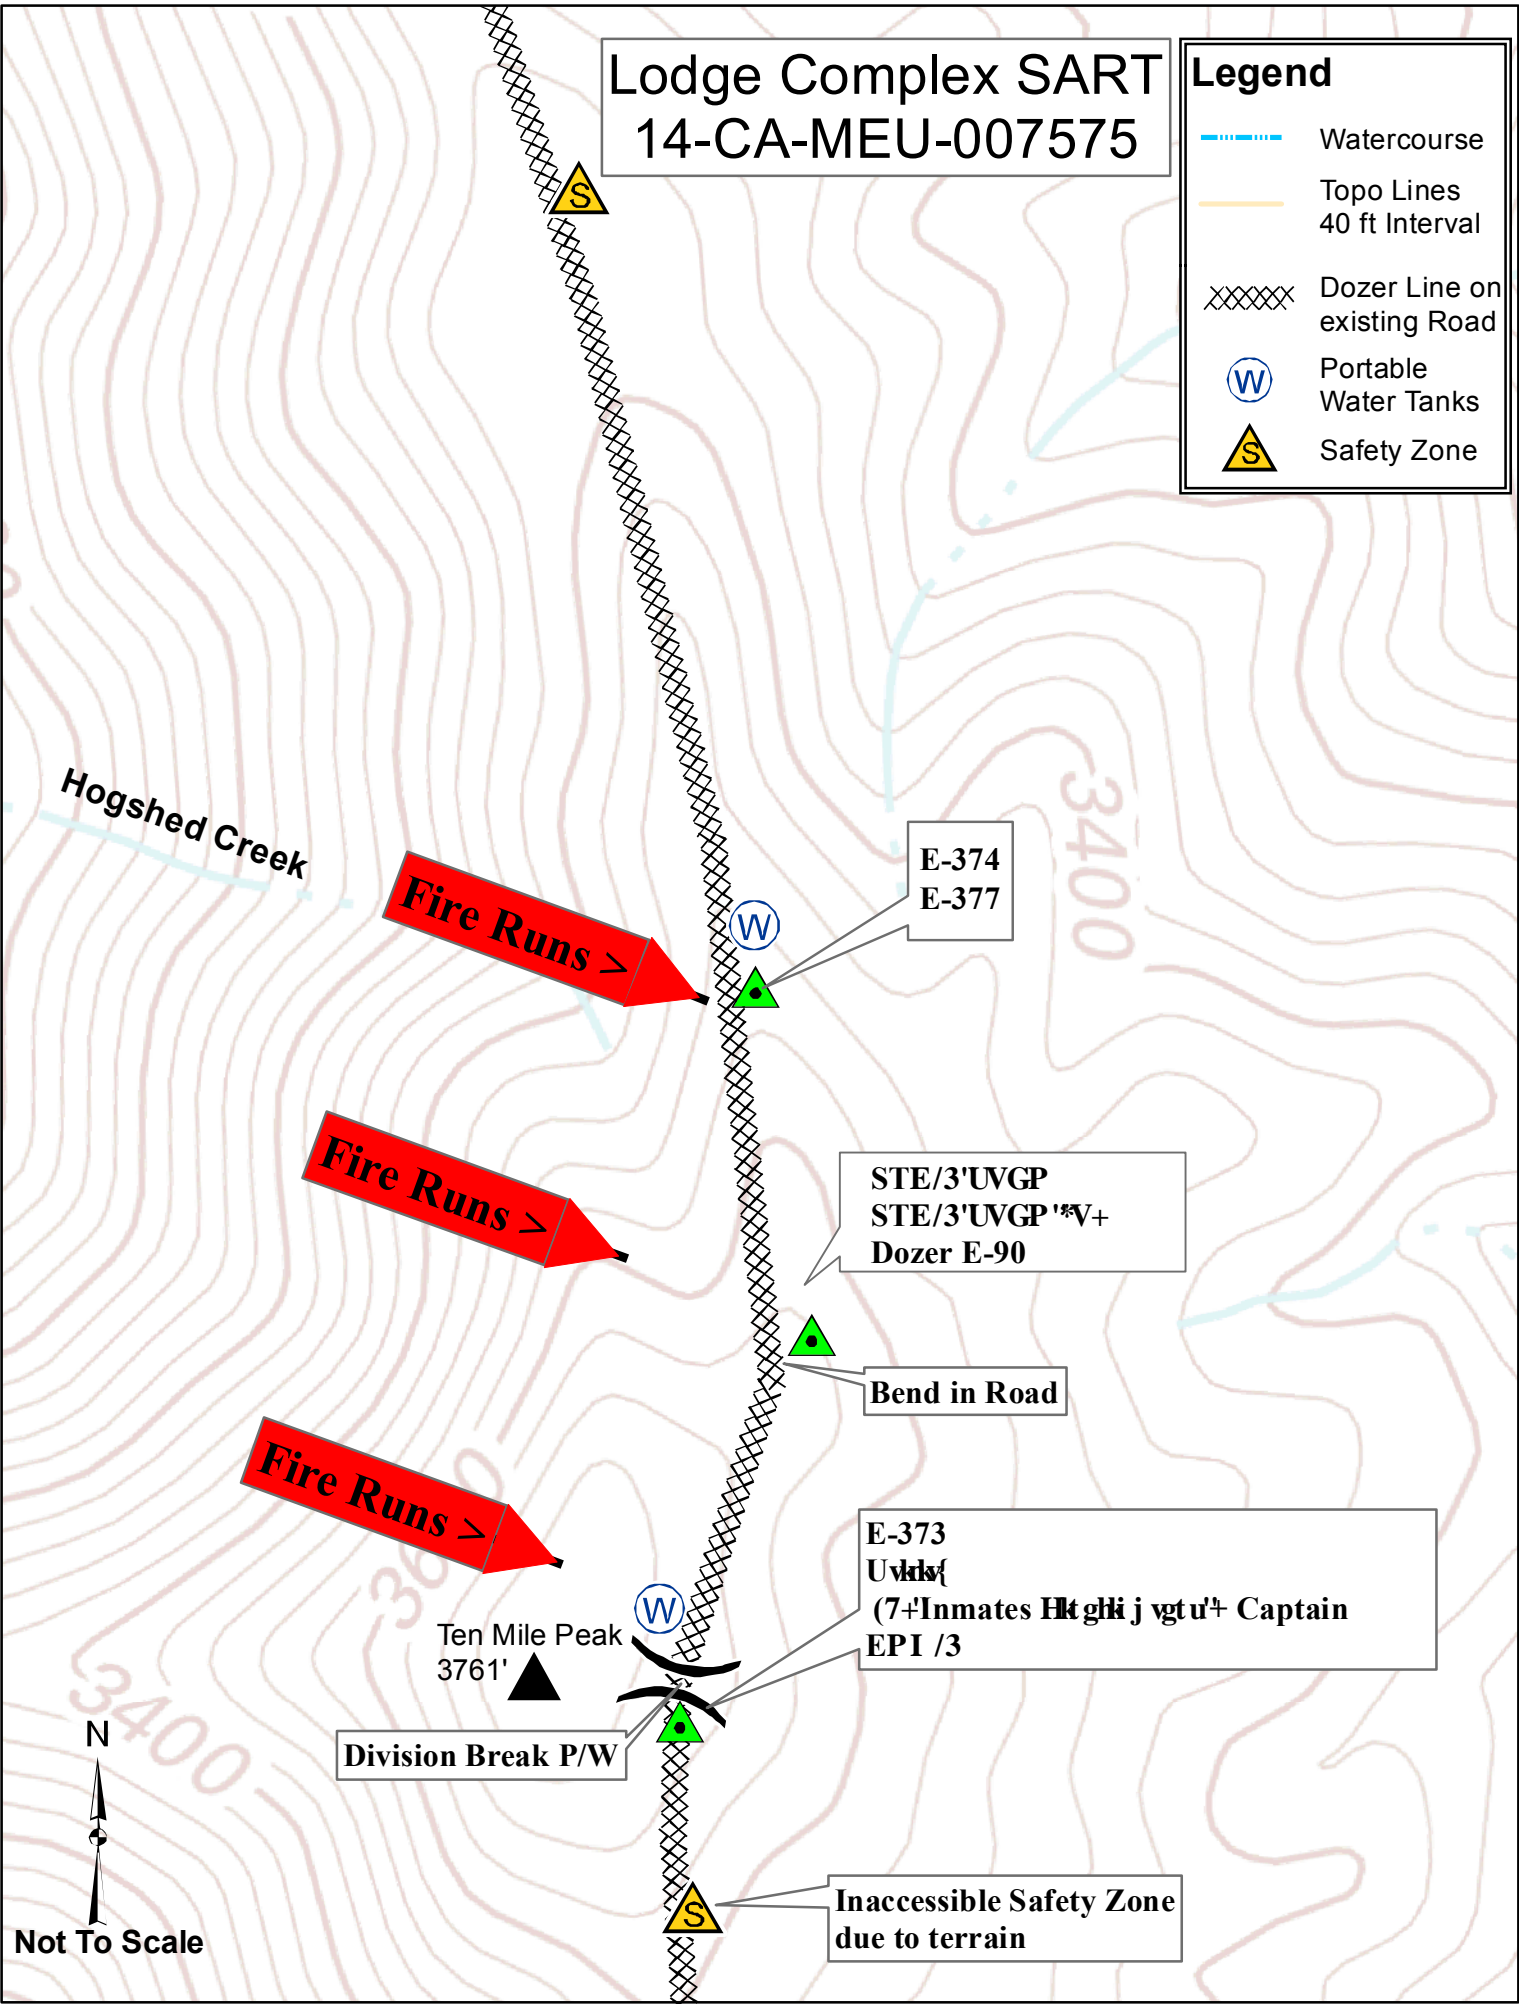
Lodge Complex SART 14-CA-MEU-007575

Inaccessible Safety Zone
due to terrain
