# GREEN SHEET

Informational Summary Report of Serious Injuries, Illness,  
Accidents and Near-Miss Incidents

Structure Fire  
Burn Injury

CA SAC #13084016

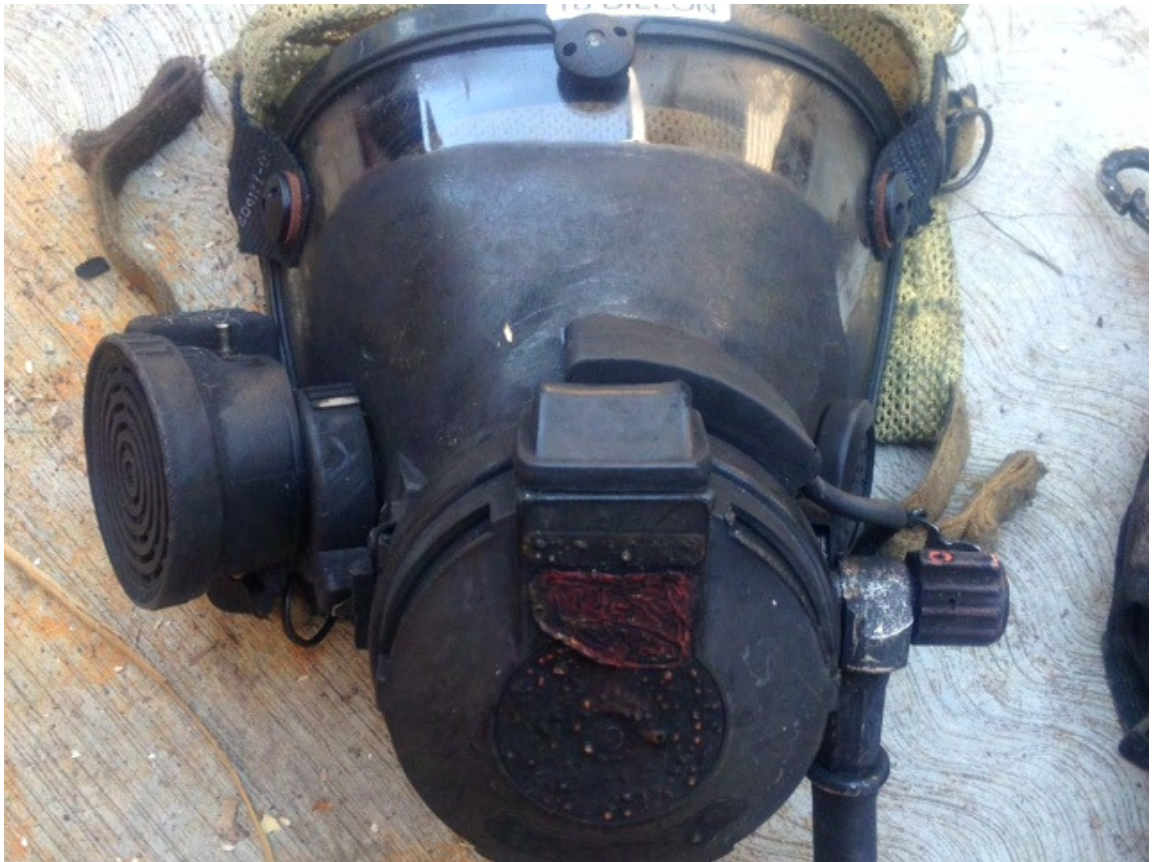
M61 Control SCBA Facepiece

from the porch. M61 Control reported that he attempted to open the nozzle on the flames, but had great difficulty in seeing through his SCBA mask and directing the hose line at the fire. His mask was completely obscured due to heat damage.

The firefighter received partial thickness burns to his fingers on both hands as well as his ears. Initially, he presented at the hospital with what appeared to be superficial burns to his shoulders, upper back, left arm, and elbow. He also experienced some redness and irritation in his eyes. All of the injuries were a result of heat contact with the body through his intact protective equipment.
