Safety Investigation Report for Incident #12050889

2828 Folsom Street, June 2, 2012

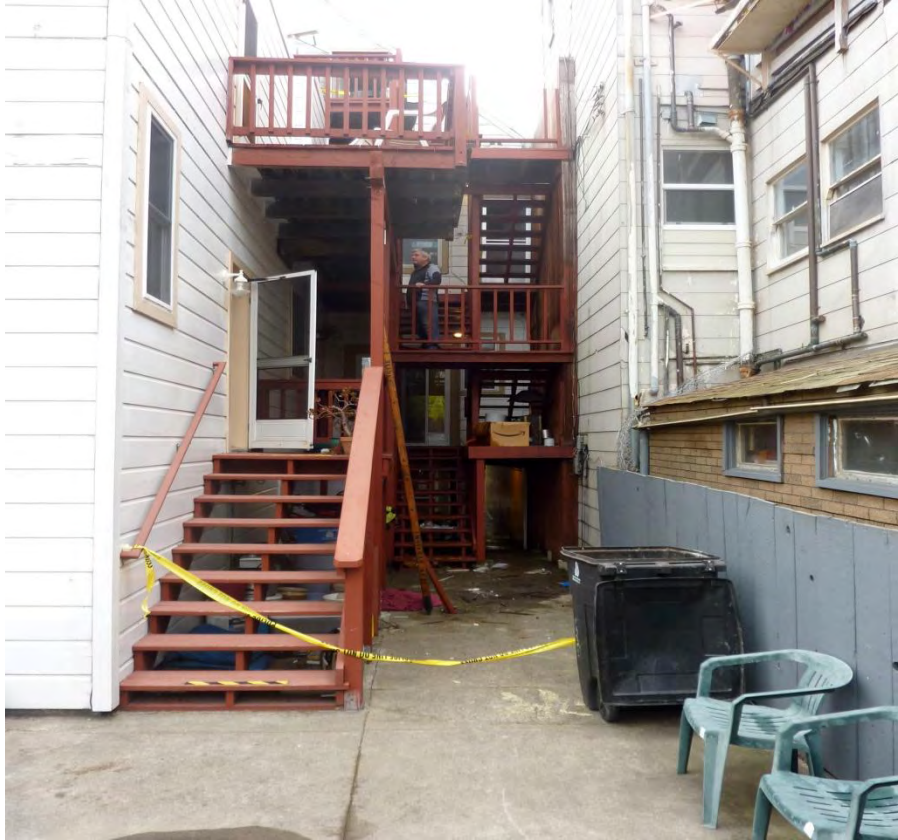
Upon arriving on scene, first units reported a small extinguished fire on the rear deck at the third story landing.

View of rear deck

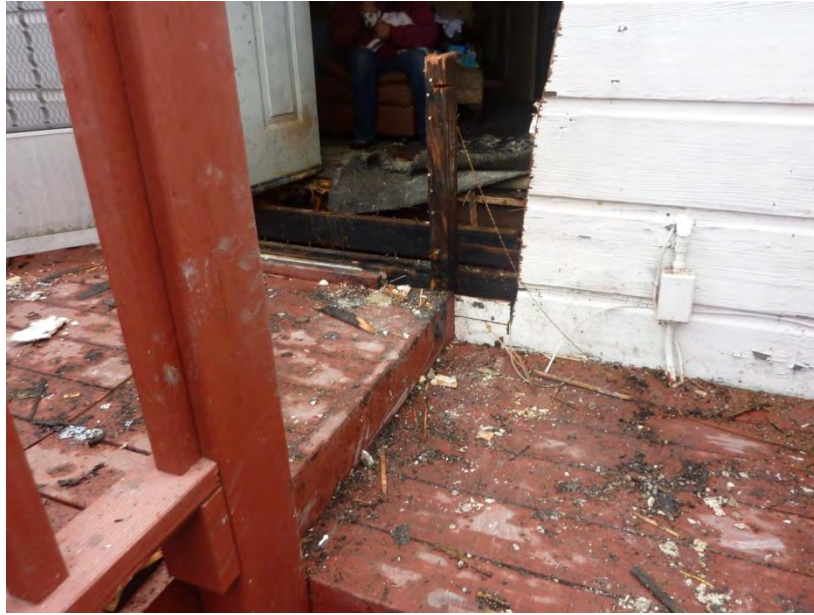
There was a planter box directly outside the exterior door where the occupant reported to have discarded smoking materials. Crews on the scene proceeded to open up the siding and the flooring inside the unit on the third floor to check for extension.

Third floor landing after overhaul

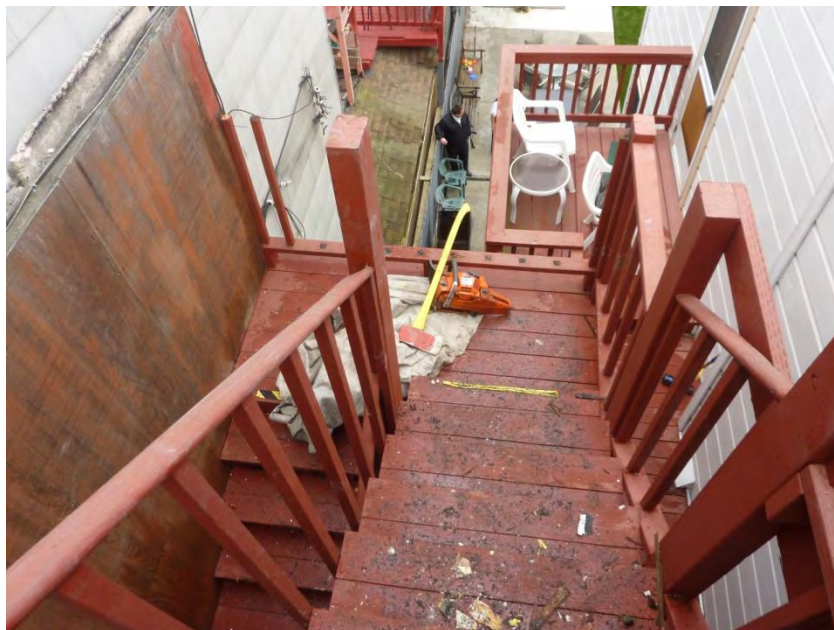
View from top landing with carry-all and contents

At this incident, the carry-all was loaded with debris and tools. The PX used both hands to carry the load down the stairs, instead of using the handrail for support and balance.

- **Make sure carryall loads are of manageable shape and weight to keep control of the load at all times.**
- **Keep one hand on handrail at all times when descending stairs with a load.**

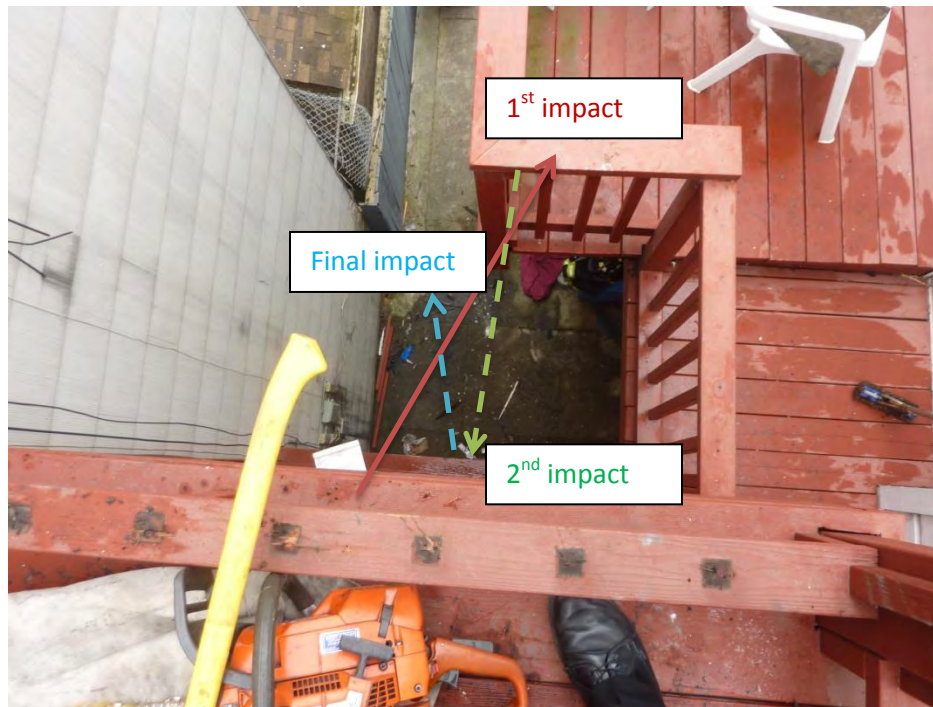
PX (Probationary Firefighter) and FF/PM (Firefighter/Paramedic) of E7 were descending the top flight of stairs. After FF/PM made the turn to proceed to the next level of stairs, PX slipped, tripped, and fell against the guardrail. This guardrail gave way and PX fell approximately 26 ft. (25'9") to the pavement below.

View from fall point. Notice water on deck.

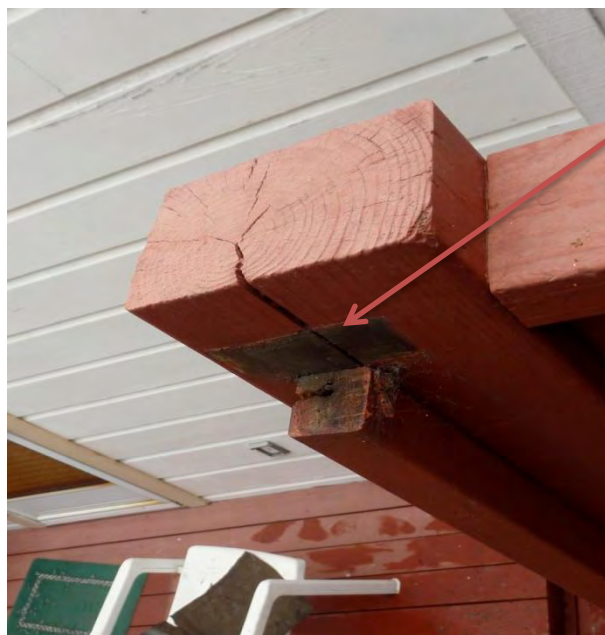
Guardrail connecting point

- "It appears that the guardrail gave way due to possible force of impact.

- Short nails (one 8p nail) on each side.
- Wood shrinkage and some wood deterioration around nails."

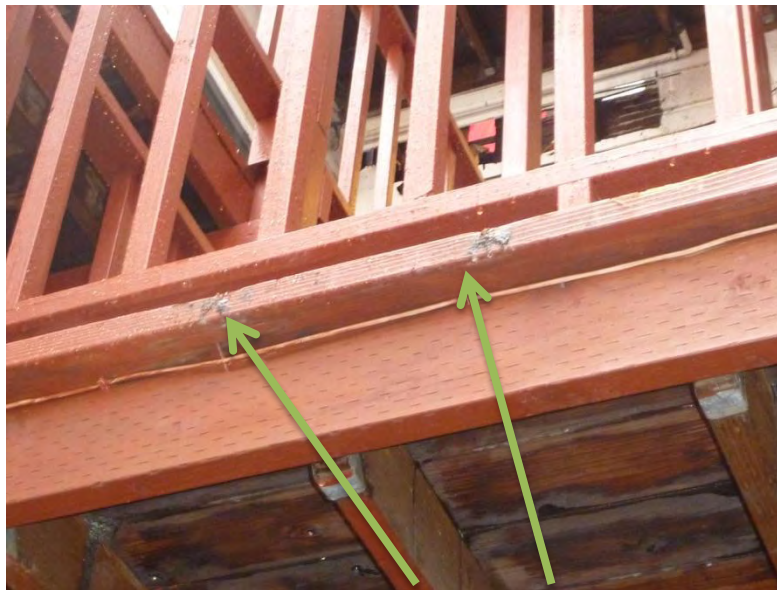
PX first broke his fall by hitting the top of the second floor railing with his shoulder area. PX continued to fall where his feet struck the base of the landing between the first and second floor. These impacts shifted his landing position from head first to shoulder first. PX landed on the concrete patio and was immediately assisted by crew members.

2nd point of impact

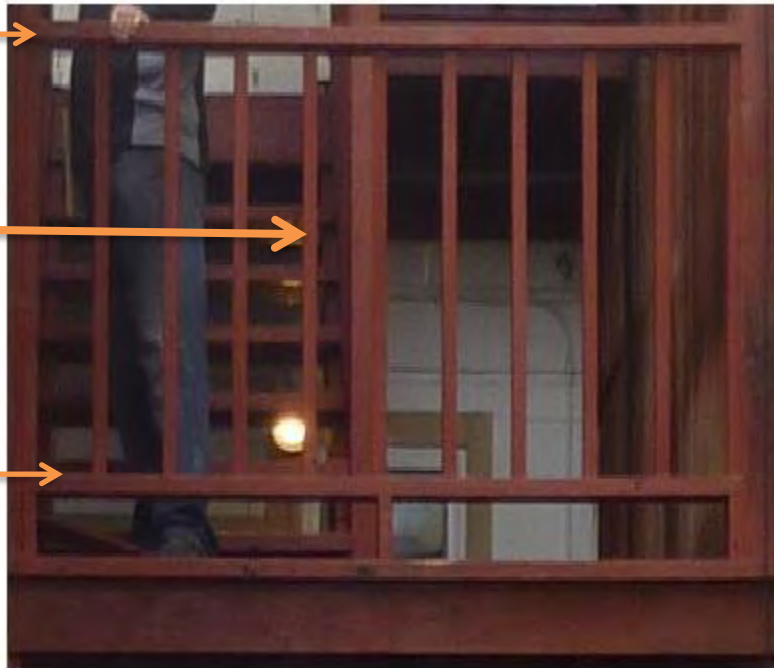
2nd floor deck guardrail, same construction as failed guardrail.
Connections were made with 8p nails.

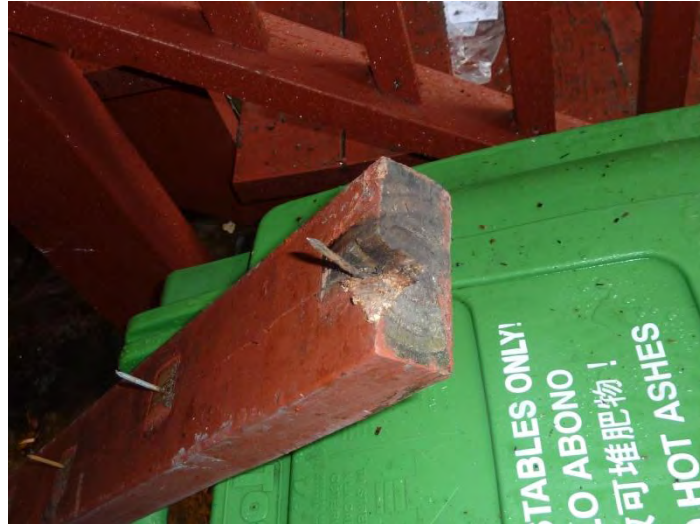
Handrail found at ground level. Note size of nails

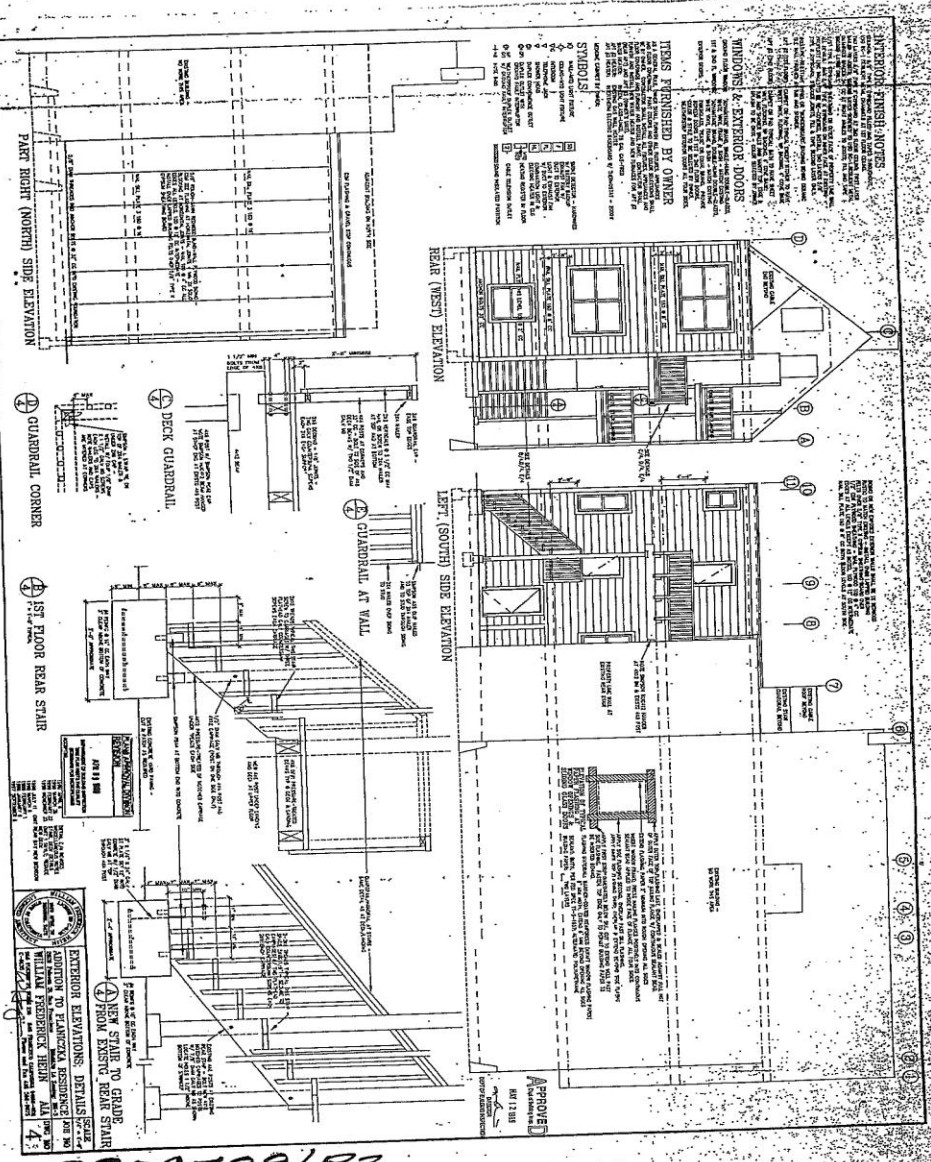
Figure 1 Plans as submitted to SFFD by D.B.I.

Plans provided (see figure 1) were stamped approved May 12, 1999. The plans reflect that the guardrail that failed was existing at the time of the remodel of the deck and stairs (May 12, 1999). The scope of the permit issued in 1999 did not encompass the stair landing guardrails, therefore it is unknown as to the date of construction of such guardrail and whether it met the codes existing at that time.

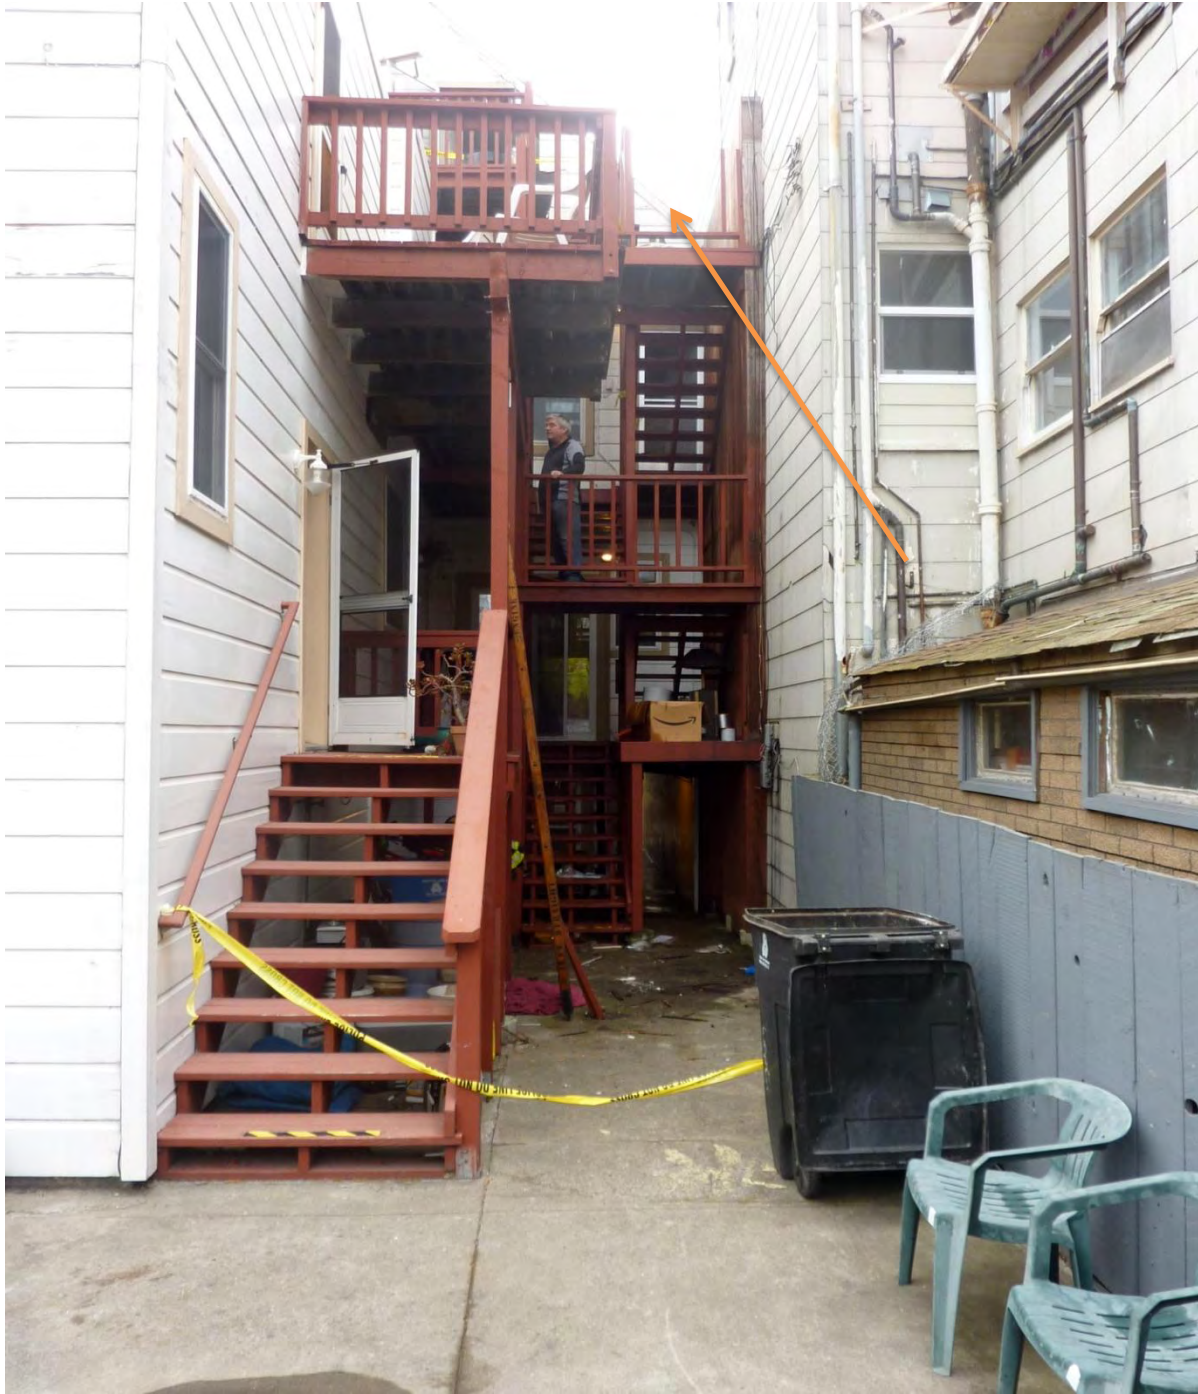
Rear deck view with arrow pointing to area of guardrail failure
