**Informational Summary Report of Serious or Near
Serious Injuries, Illnesses and Accidents**

GREEN SHEET

Training Burn Near Miss

Incident Number 18-CA-MNT-0002755

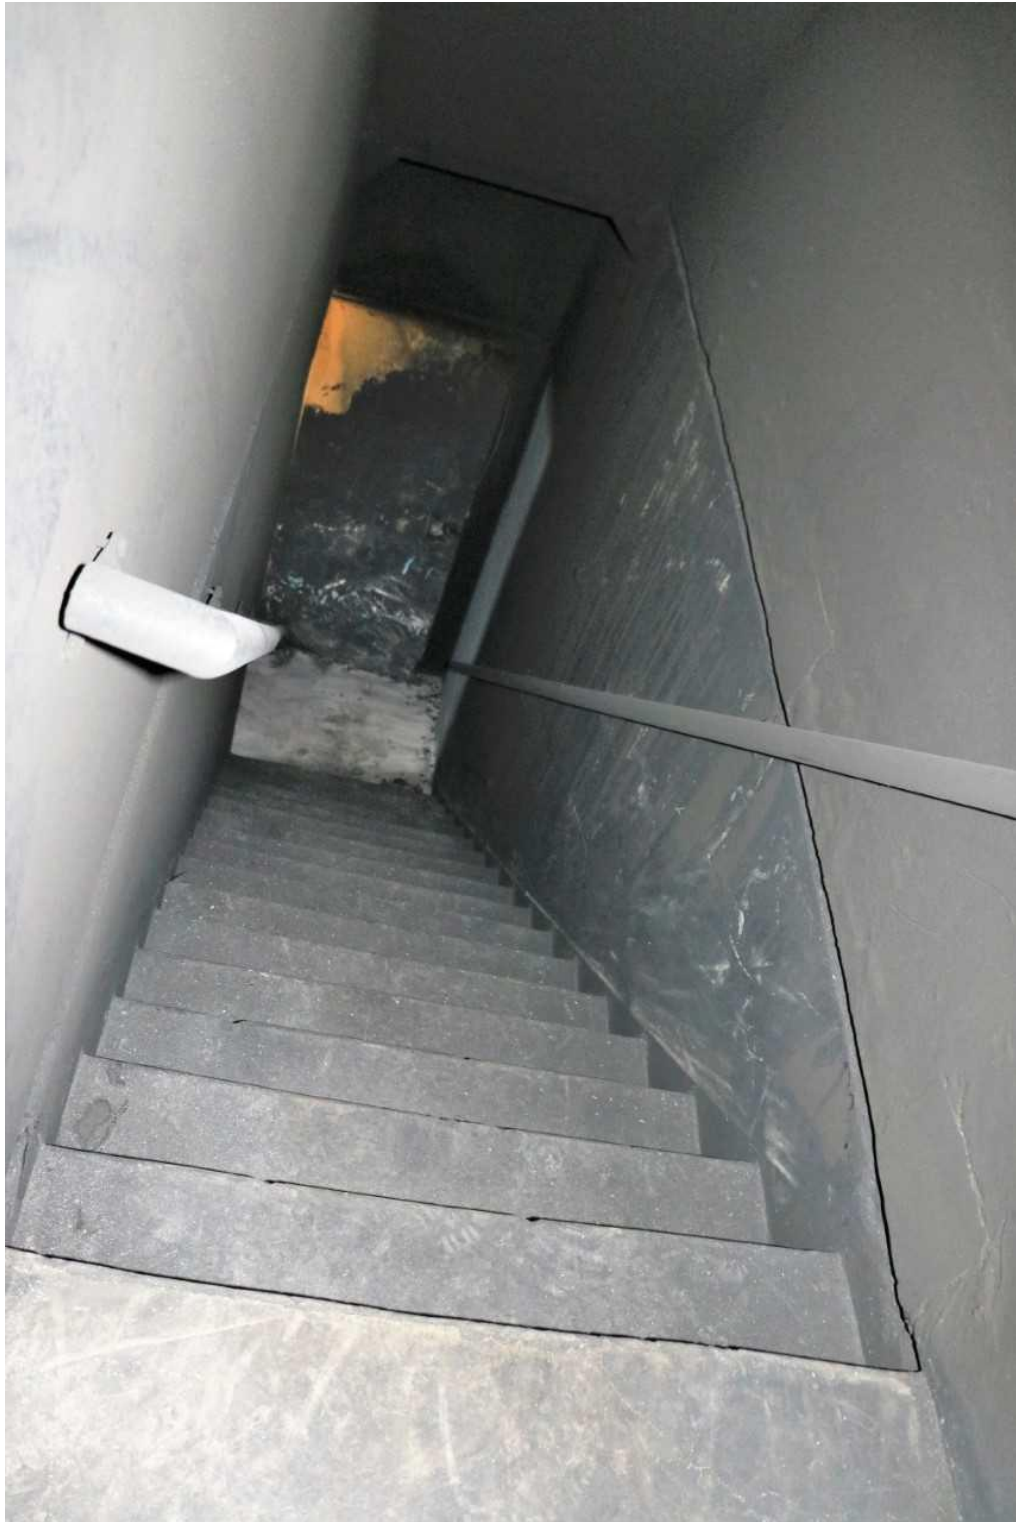
Interior Access Stairway down to Burn Room

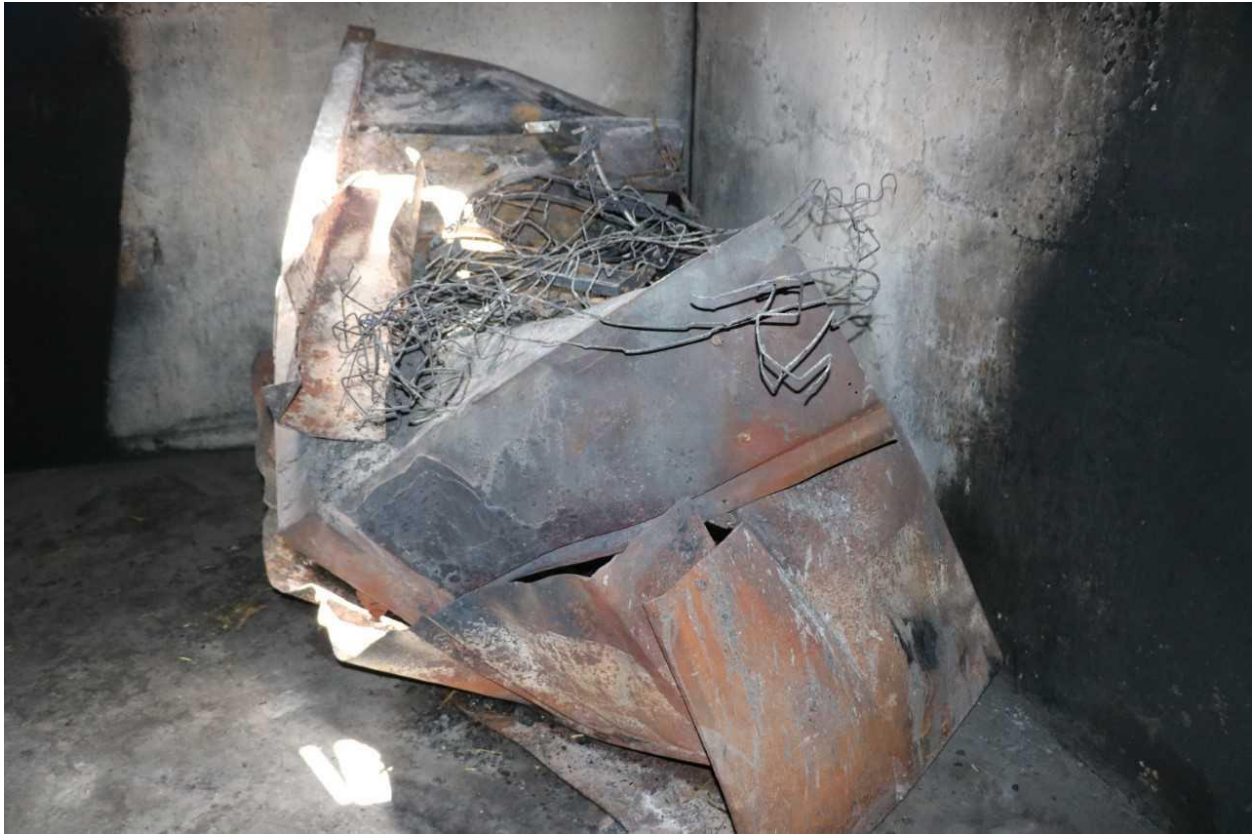
Burn Crib with metal parts of recliner base on top

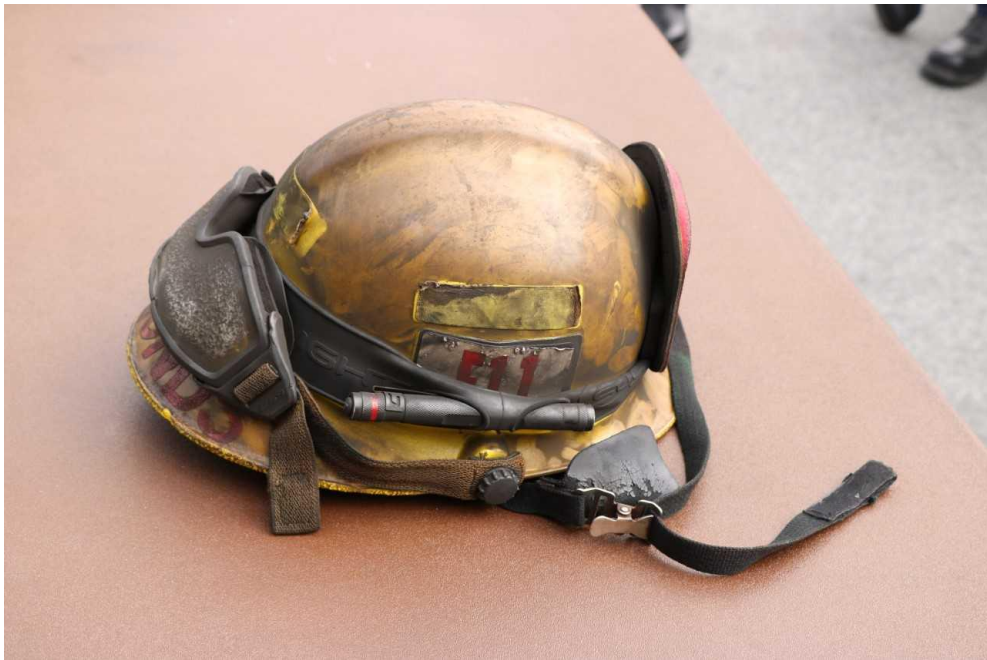
- First and Second degree burns to 9% of the body occurring on the head, neck, back, shoulders and forearms.
- The FF PPE including helmet, goggles, hood, SCBA and jacket suffered varying degrees of thermal damage.
- The Radio utilized was issued by MPC Fire Academy and was not a current fire service rated radio. The thermal insult melted the radio rendering it out of service.
- While conducting interviews, it was determined that three other Monterey Fire Dept. structure helmets had been melted in previous burns in the weeks prior to this incident.
- The Salinas Training Tower was built in 1966 and had notable damage, including exposed rebar, throughout the building.

Helmet showing damage to goggles and brim

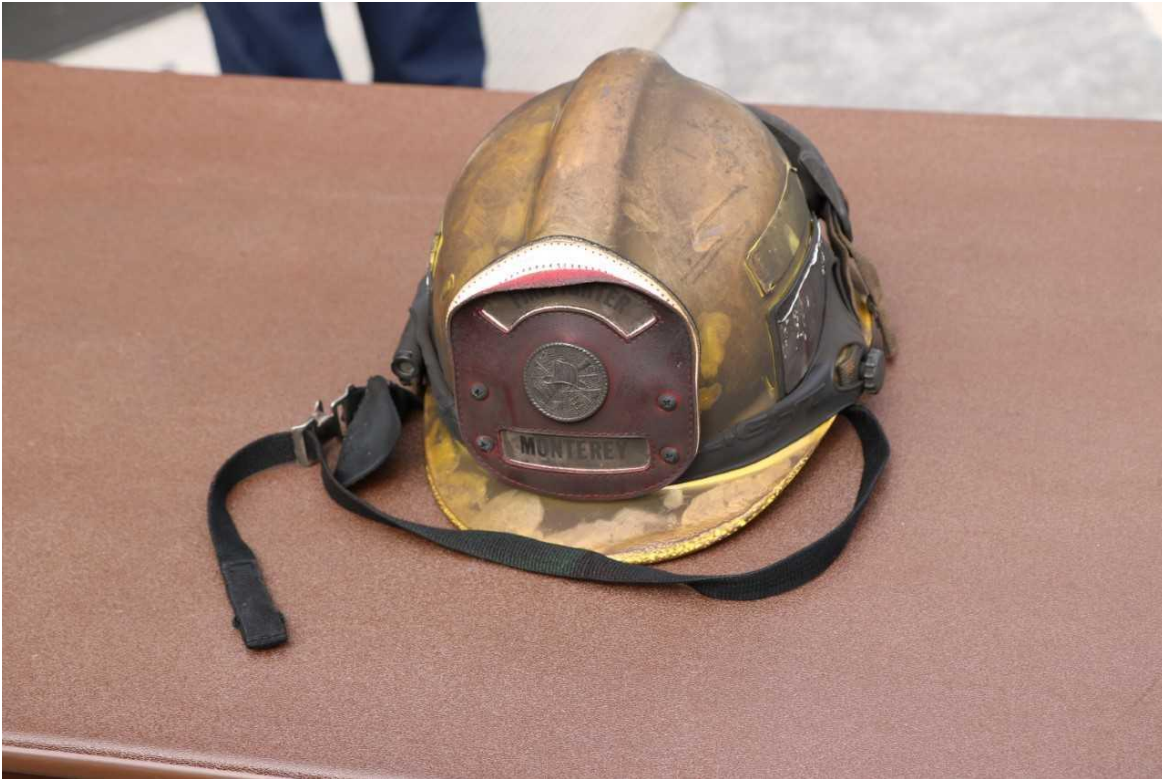
Helmet showing damage to Shield

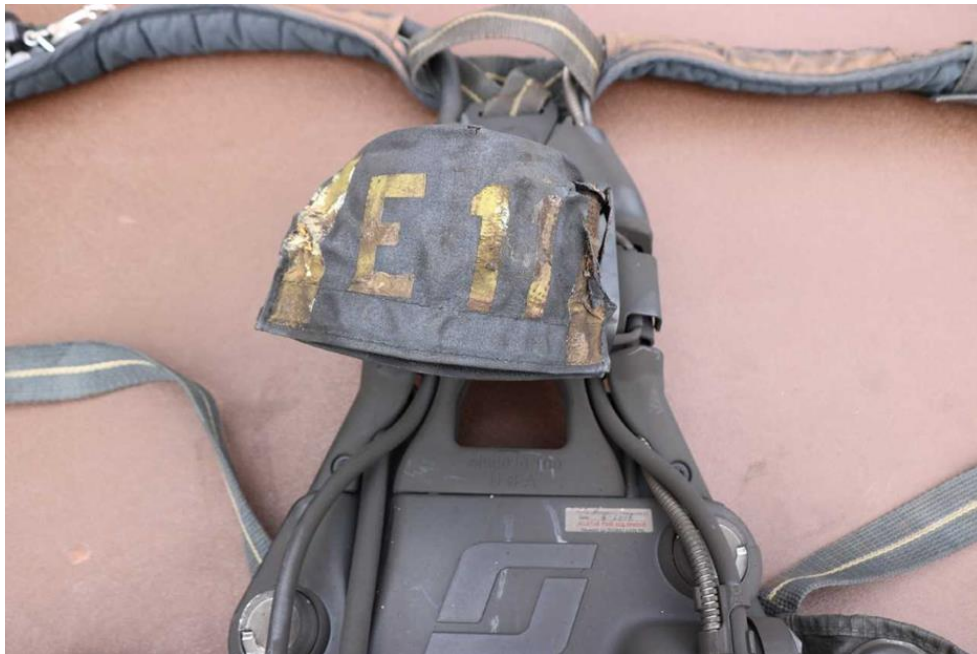
SCBA showing damage to Pack
