# Informational Summary Report of Serious or Near Serious CAL FIRE Injuries, Illnesses and Accidents

## GREEN SHEET

### Structure Fire Burn Injuries

Young Commercial Structure Fire

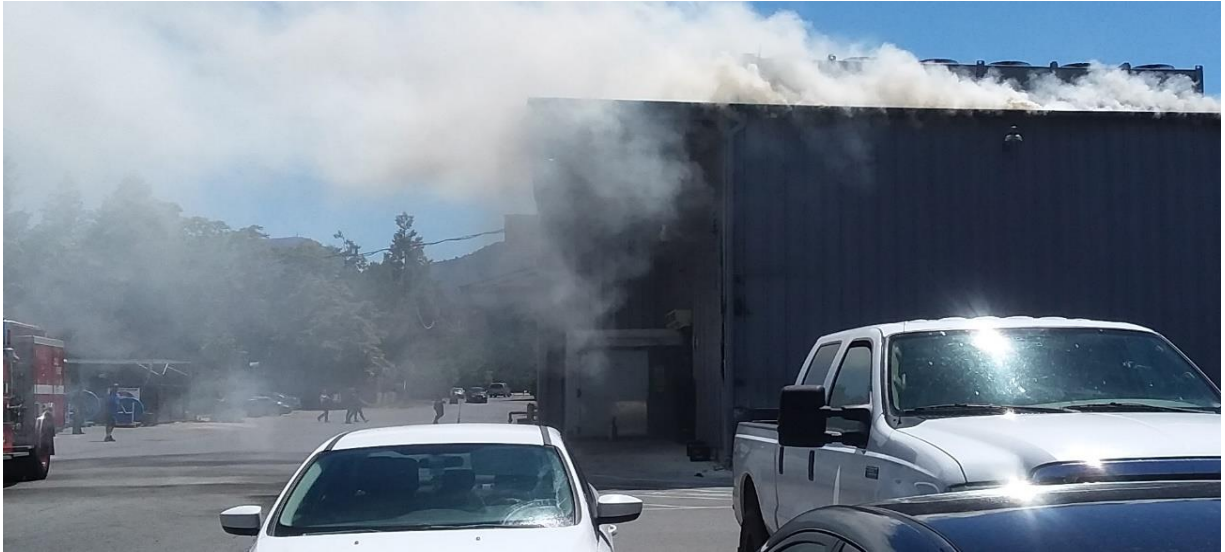
**Fire Behavior:** Upon arrival, the first engine observed light smoke visible at the Charlie/Bravo corner near the roof line. Flames were seen through a small opening on the Charlie/Bravo corner at street level.

E1 arriving at scene, conditions observed at 2:23 PM.

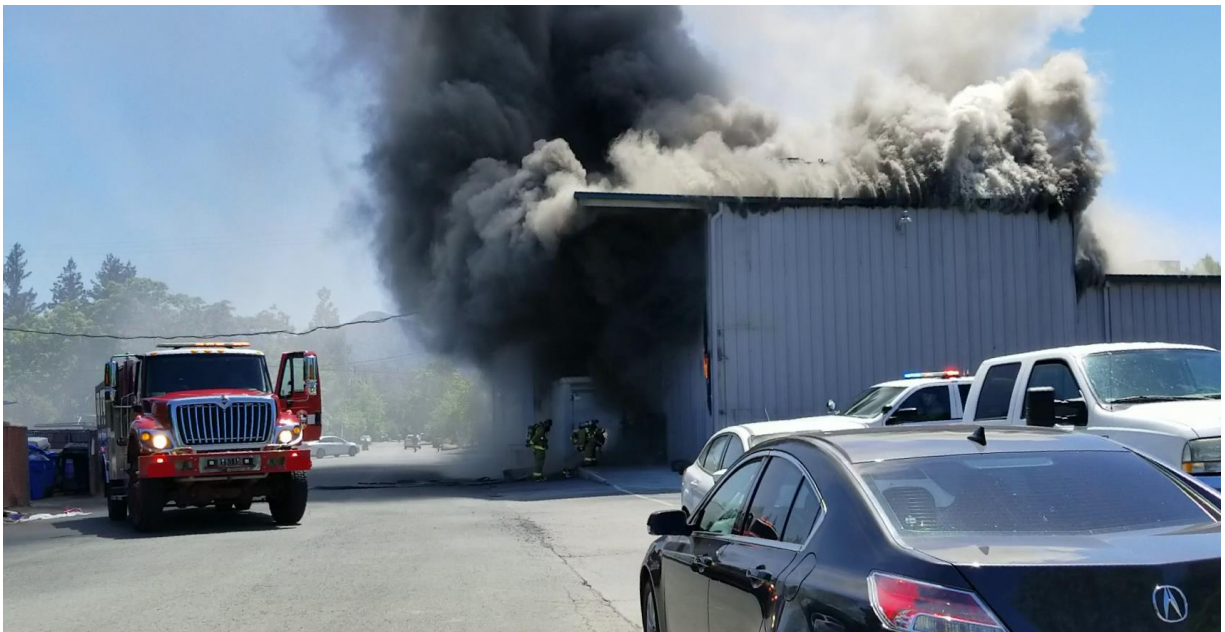
FAE1 spotted the engine approximately 20 feet beyond the corner of the structure, then engaged the pump. FF1 and FF2 donned their Self Contained Breathing Apparatus (SCBA). FF2 deployed the rear 1 ¾ inch preconnected attack line and flaked the hose in preparation for an offensive attack. FF1 positioned at the rear service door with the nozzle and waited for FF2 to don his SCBA mask. The service door consisted of a combined man door and small rollup door. FF1 and FF2 applied water from the threshold into the structure. FF1 and FF2 advanced the line to an interior position approximately three feet beyond the door opening and continued fire attack. FAE1 did not know FF1 and FF2 entered the structure.

FF1 and FF2 deploying attack line and preparing for offensive attack at approximately 2:24 PM.

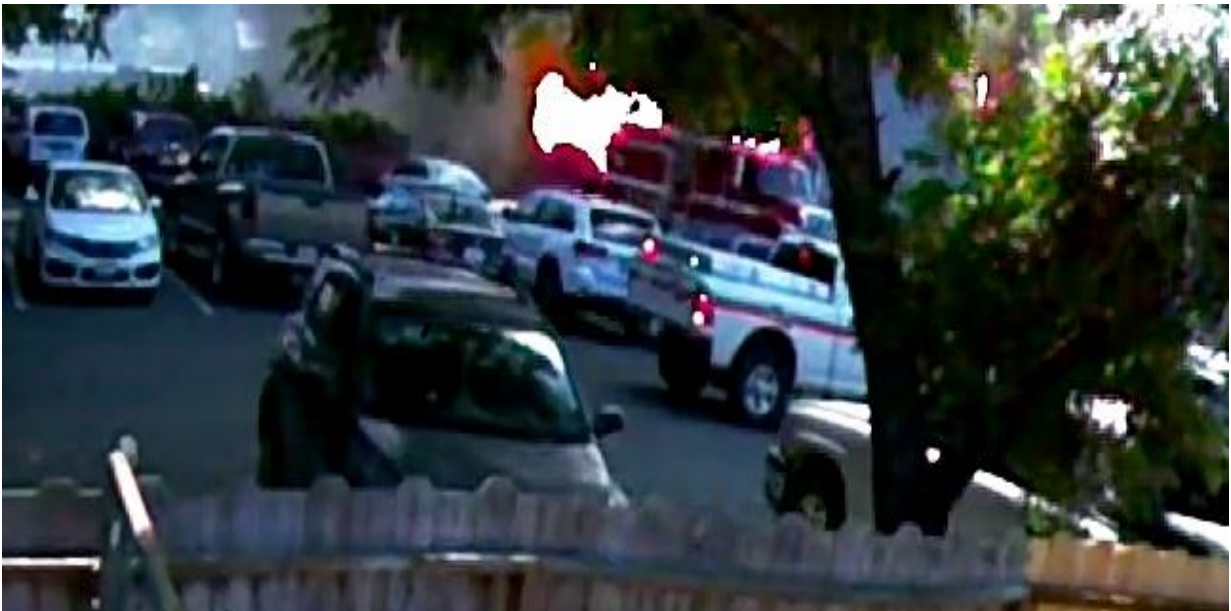
Due to an increase in fire activity and the proximity of E1 to the structure, FAE1 made the decision to reposition E1. FAE1 was unaware that FF1 had exited and FF2 was still interior. FAE1 moved E1 forward approximately 20 feet. The pump was disengaged during this action, causing a loss of pressure to the attack line.

E1 is relocated while pressurized fire ball was observed from the north side of the structure.

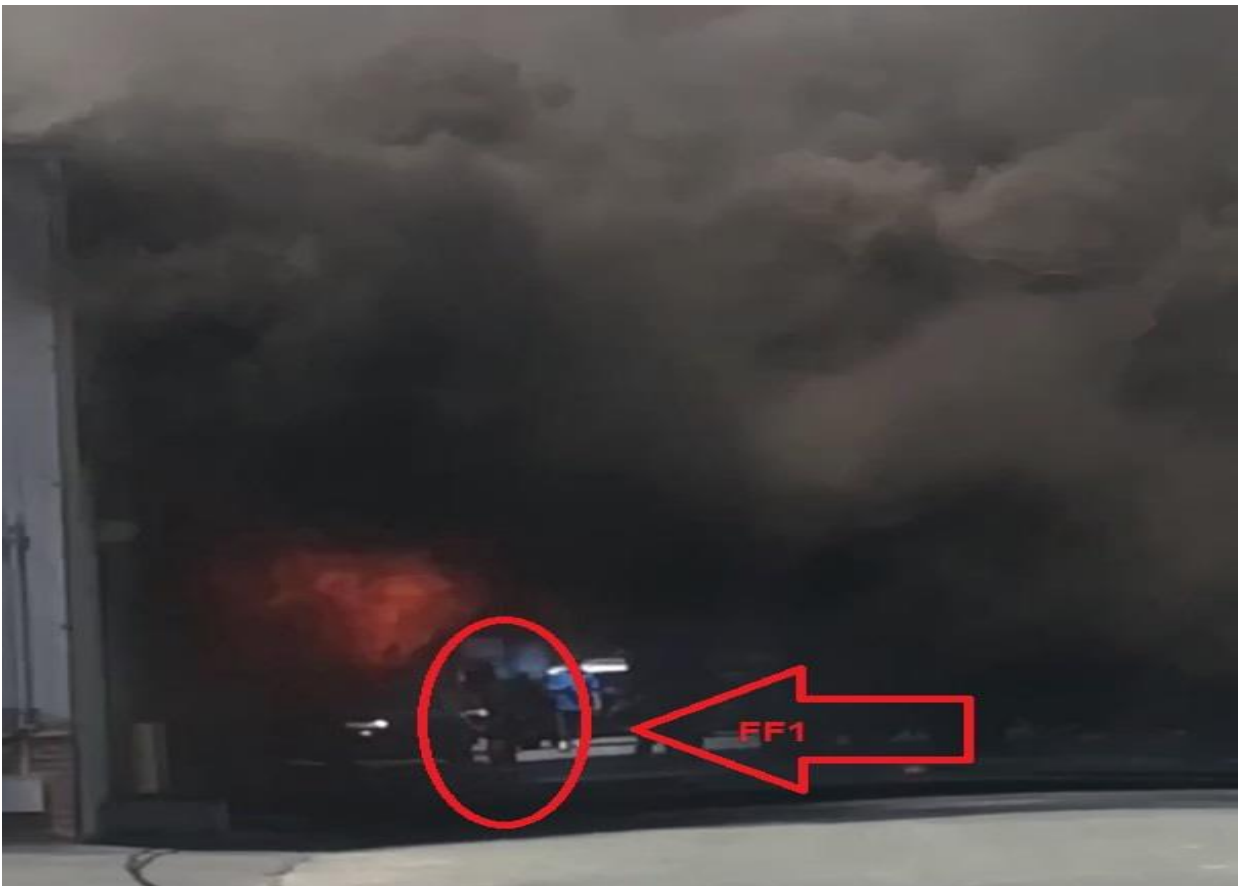
FF2 attempted to exit the structure, then ran into the same rollup door that FF1 ran into. Simultaneously the attack hose line went limp. Within seconds, there was a catastrophic failure of the structure's high pressure refrigeration lines directly above FF2. An additive to the refrigerant ignited and caused a pressurized release of flammable material. The flammable material ignited, causing a significant fire ball that completely engulfed FF2 for approximately 19 seconds. FF2 located the door and crawled out of the structure.

FF1 seen exiting while pressurized fire ball is observed from the south side of the structure.

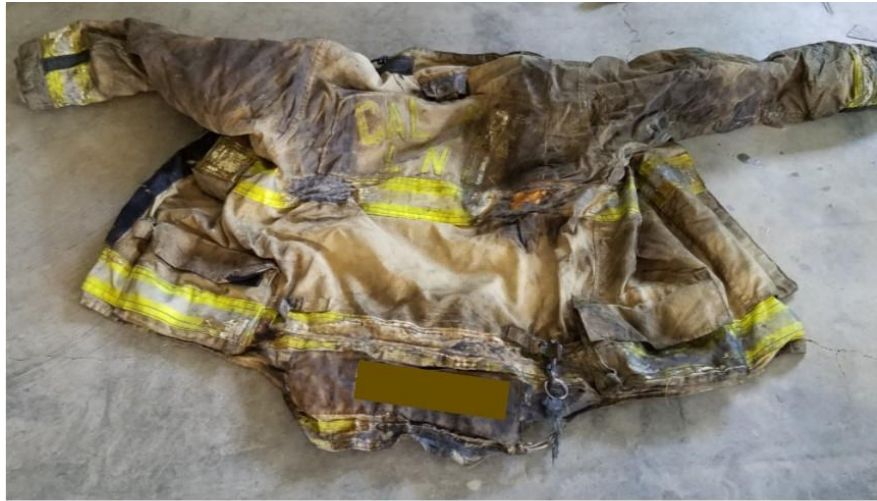
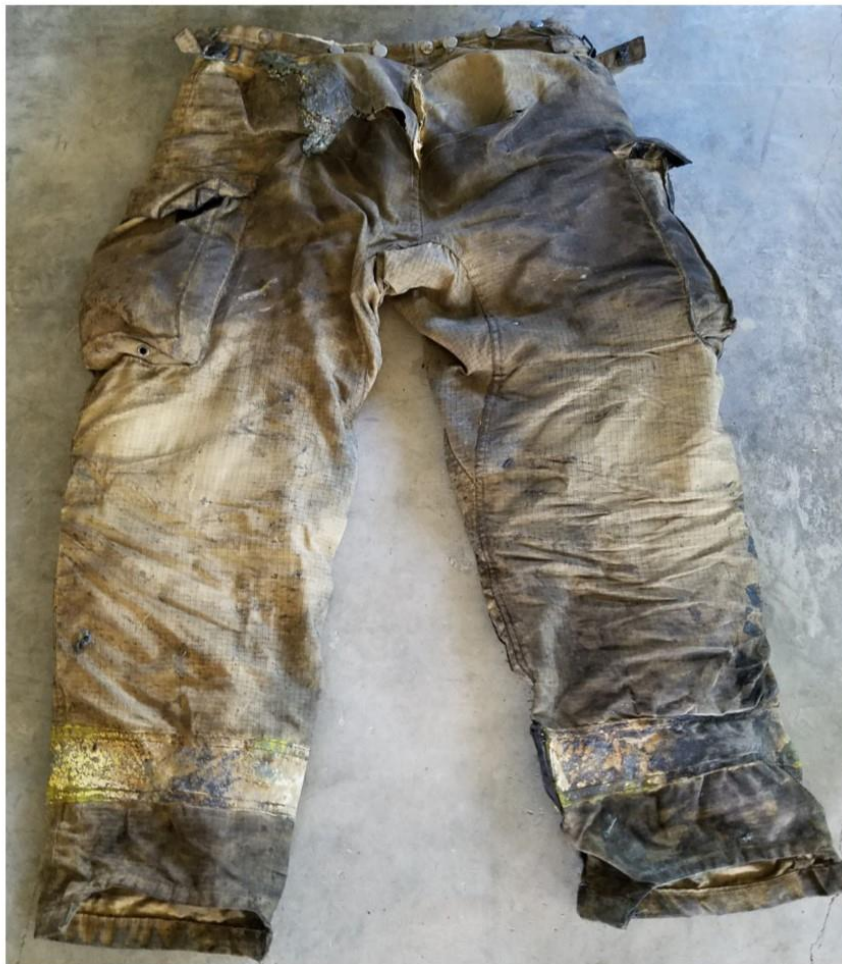
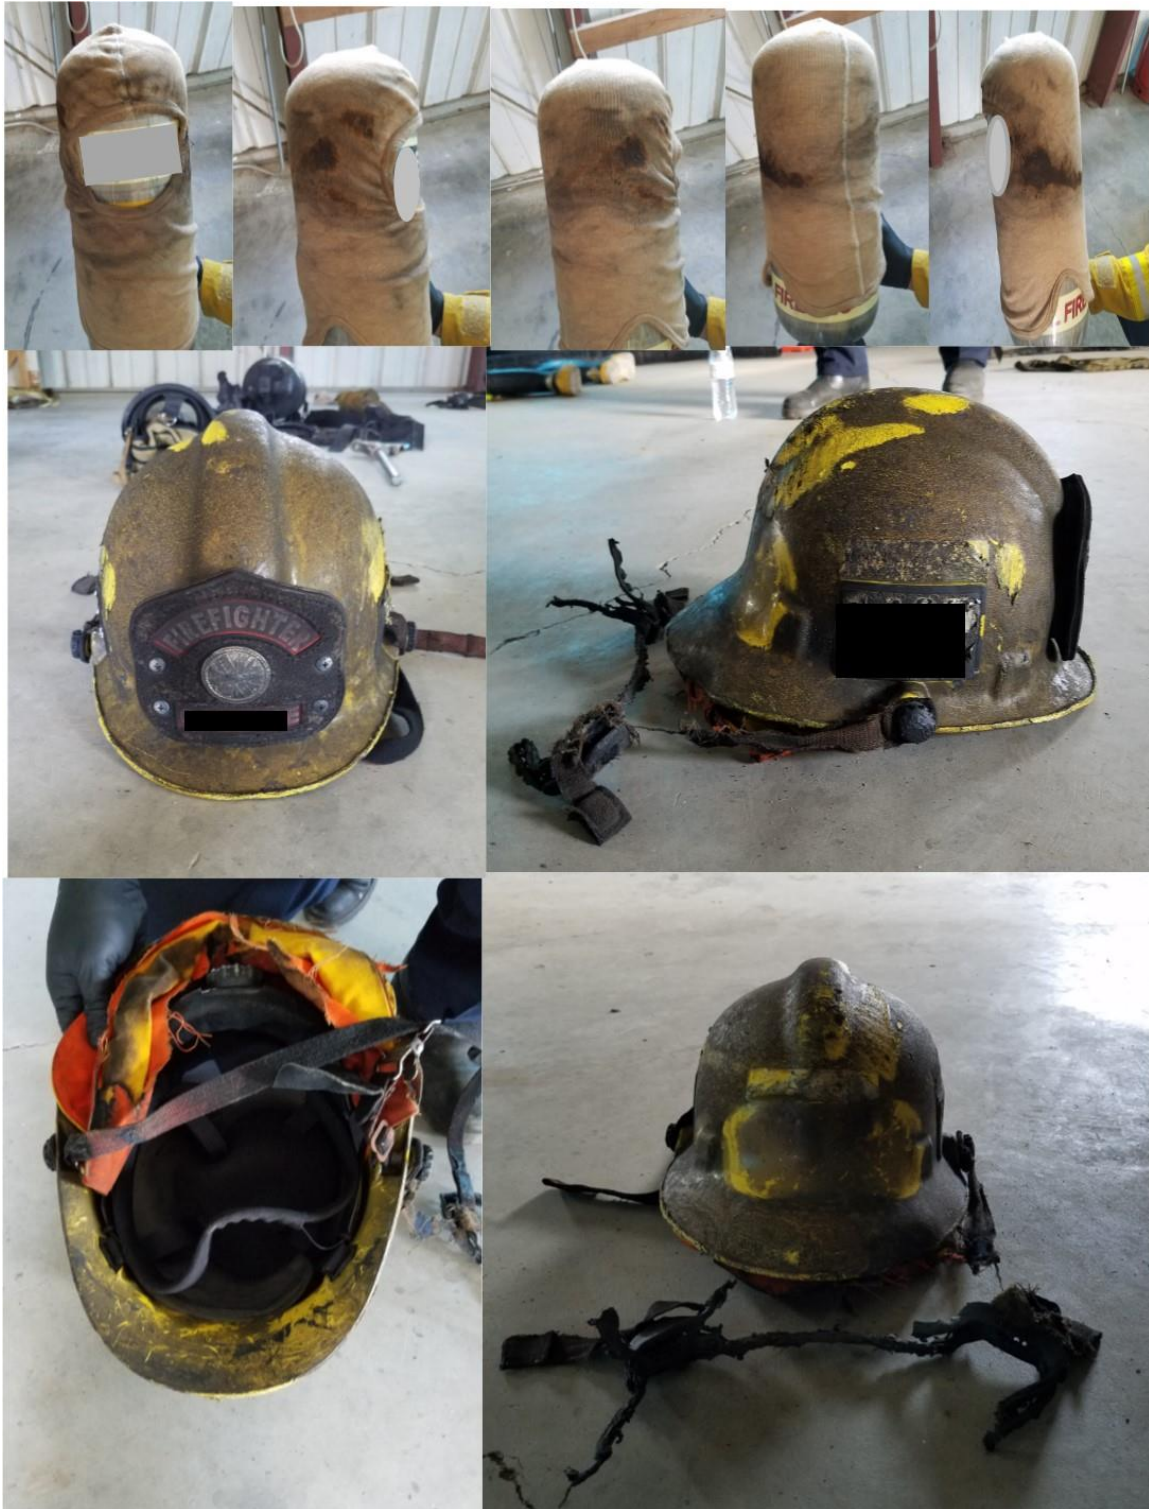
## Structural PPE

FF2 suffered second degree partial thickness burns to eight to ten percent of the body including the right ear, lower back and to the back of the arms from the shoulders to the elbows.

- The structural personal protective equipment (PPE) had a direct impact of minimizing the injuries suffered by FF2.

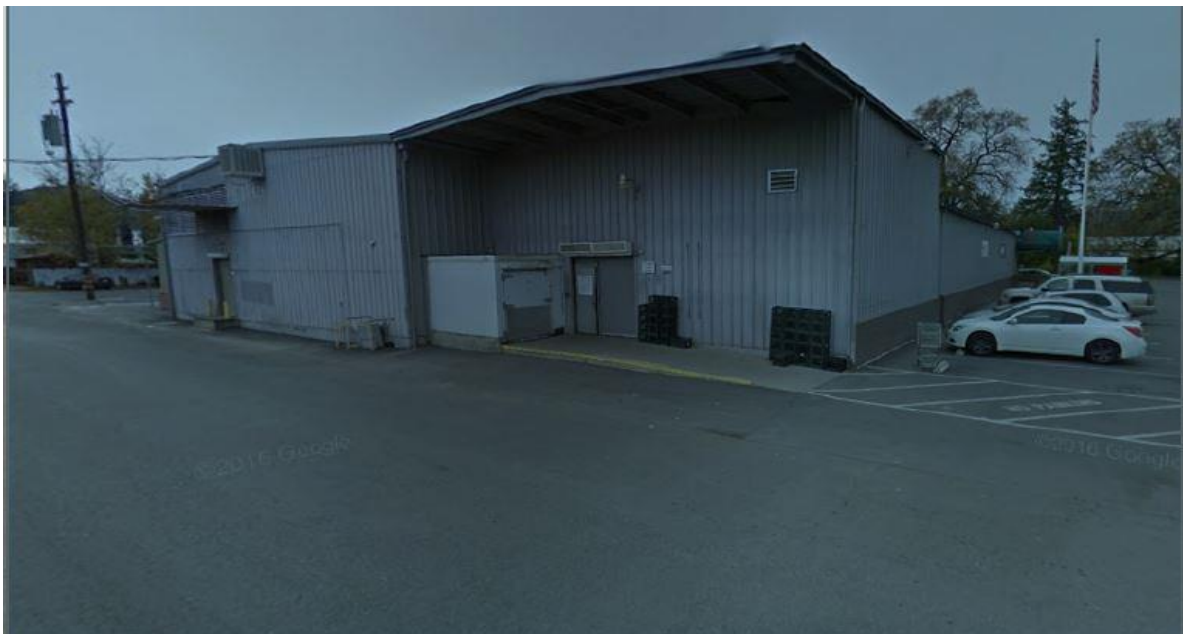
Pre-fire view of the rear of the commercial structure where injuries occurred.
