Informational Summary Report of Serious or Near Serious CAL FIRE Injuries, Illnesses and Accidents

GREEN SHEET

Bulldozer Rollover Fatality

Ferguson Incident

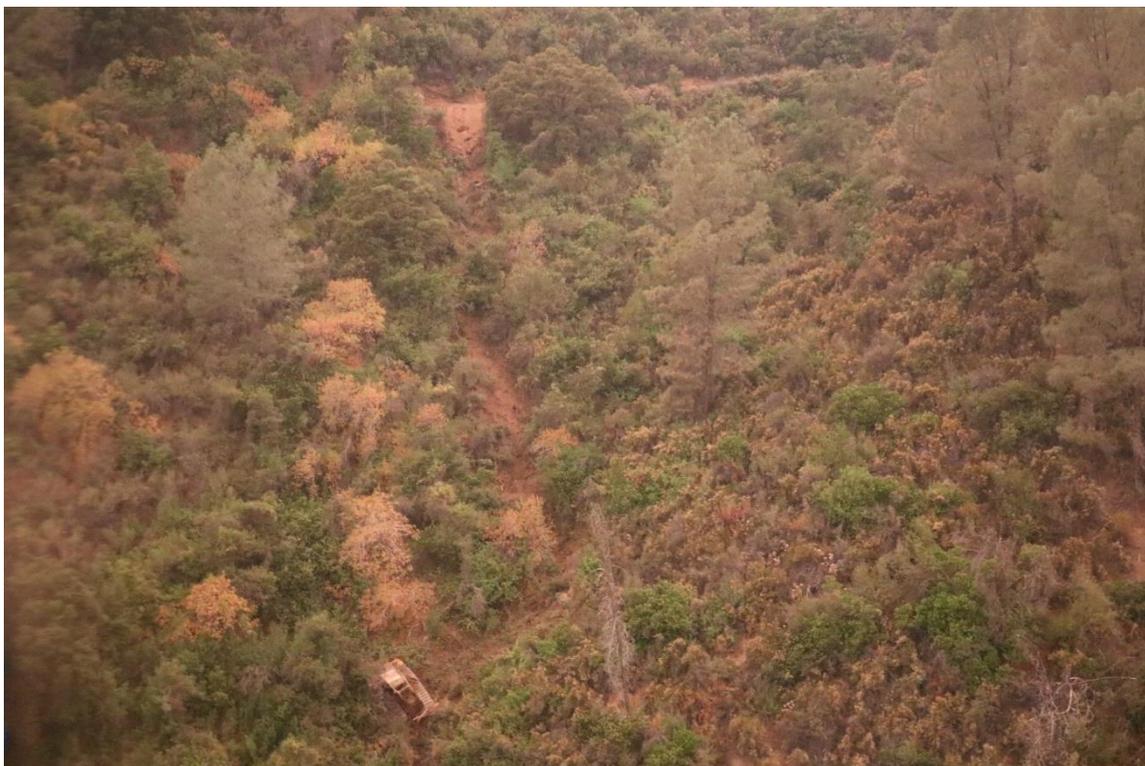
Looking at the fall line and dozer final resting place

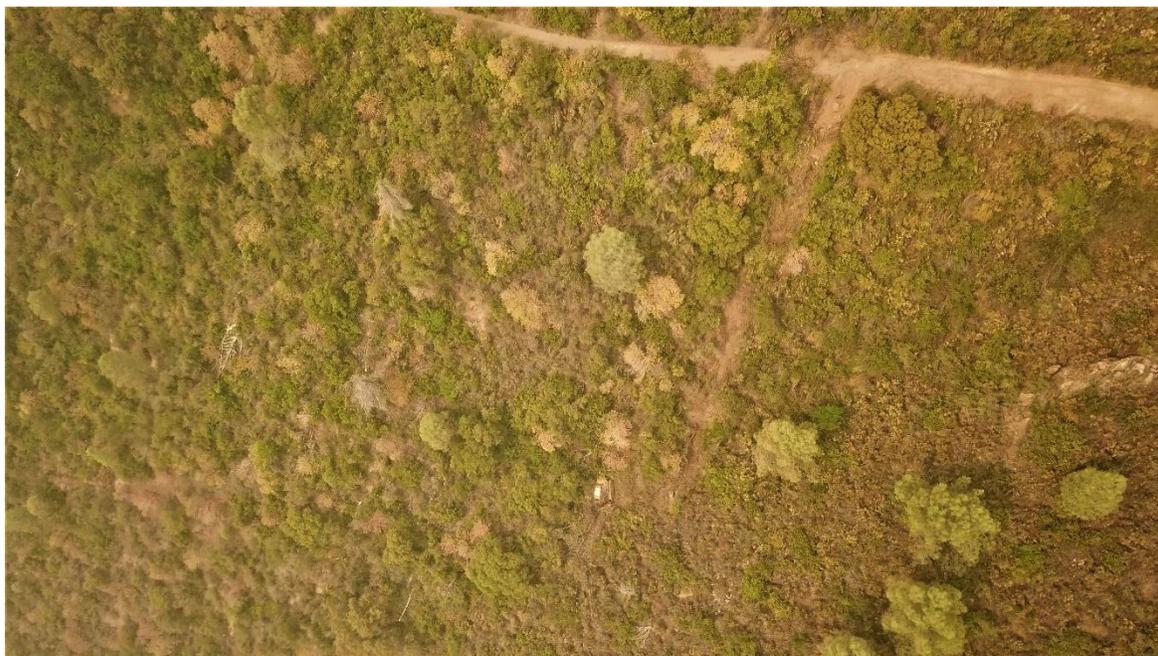
View looking at the fall line and Dozer 1 final resting place

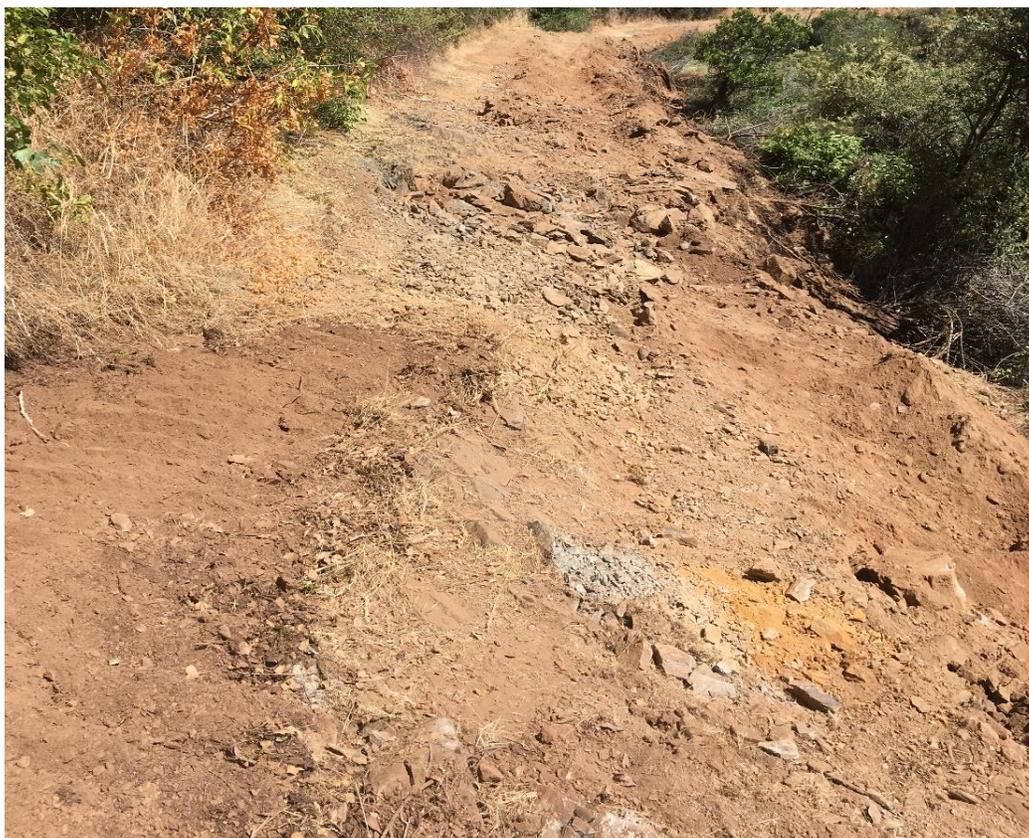
View looking north along the trail at the fall site

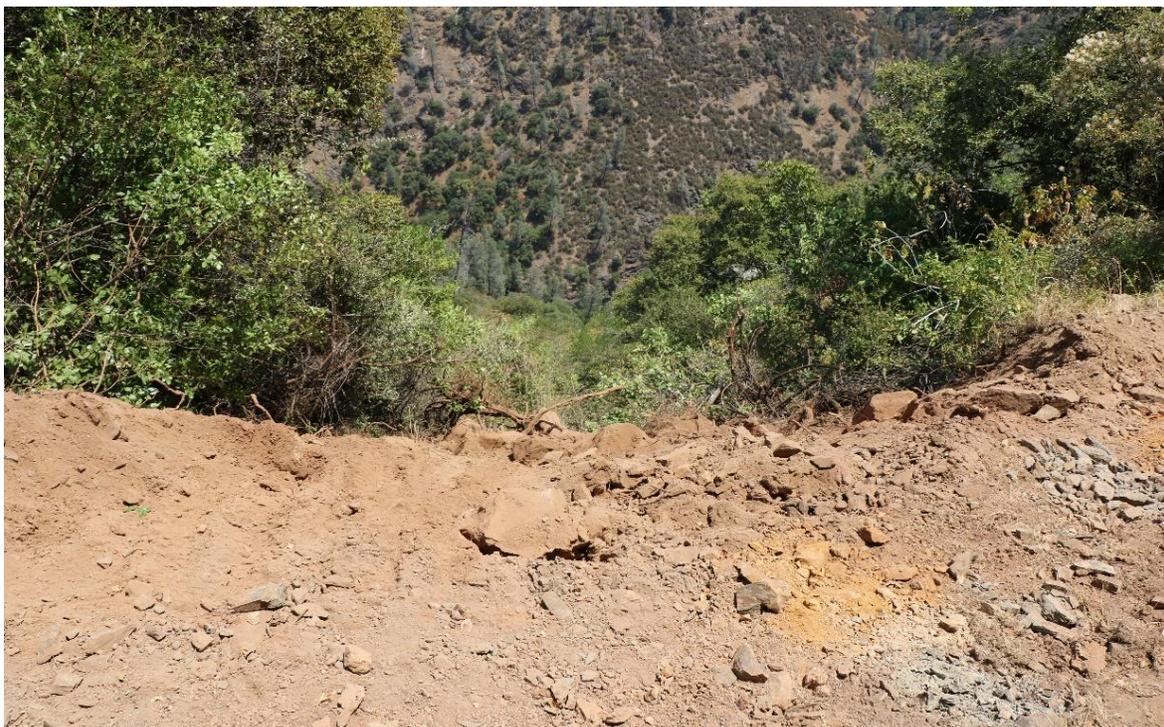
Looking east at the top of the fall site

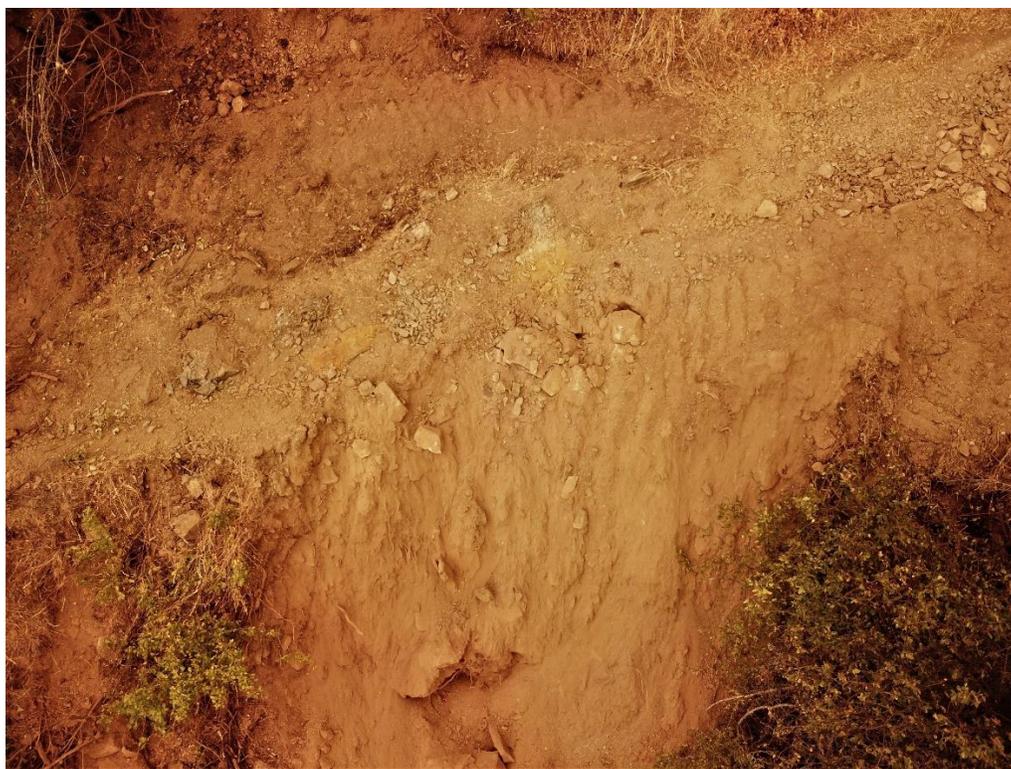
Looking down at the trail and top of the fall site

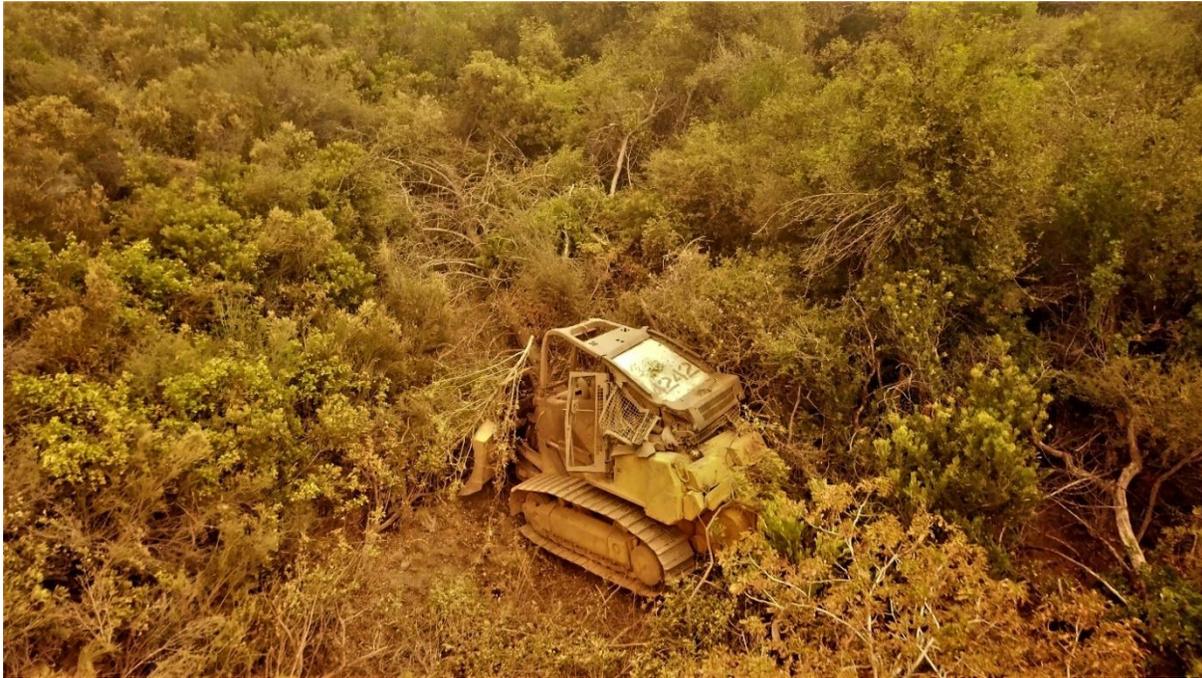
Dozer 1 final resting location

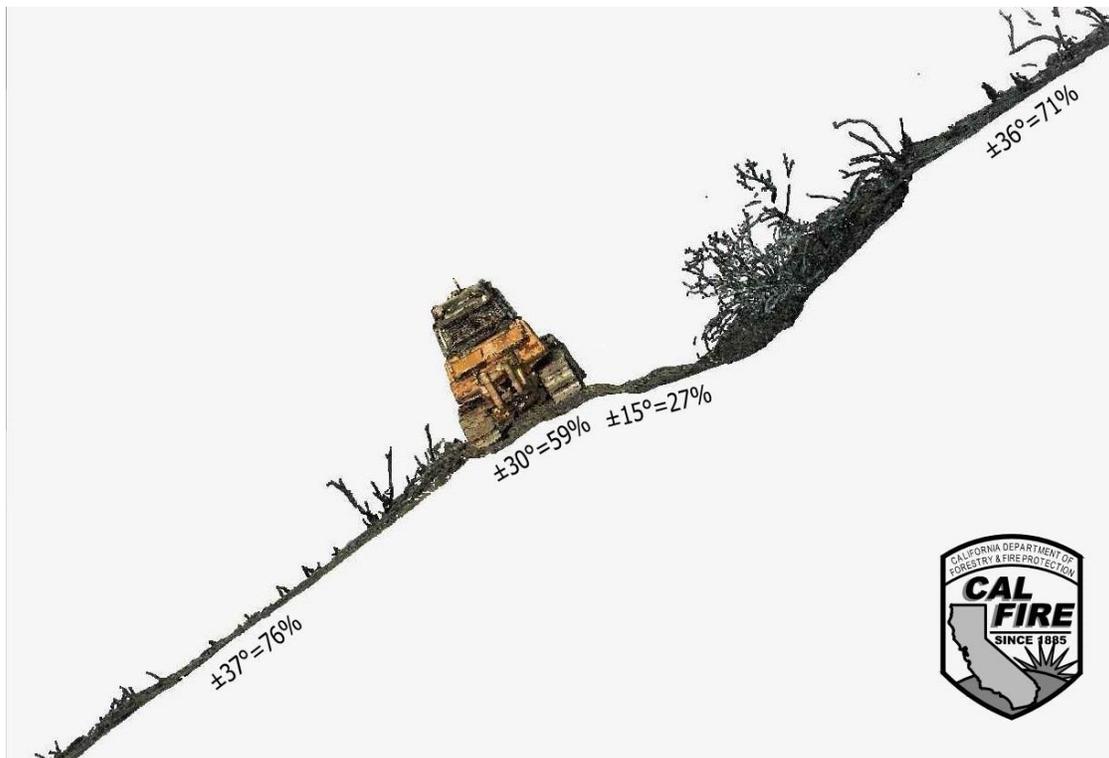
A post incident analysis of the accident scene and associated OHV trail revealed Dozer 1 had been flattening a small berm along the outside edge of the trail and ultimately widened it to approximately eleven feet. There were three slip locations, spread over several hundred feet, where Dozer 1 left the trail prior to the rollover. Each of these slips would have independently qualified as a Near Miss. The first Near Miss revealed Dozer 1 had completely left the trail, before climbing back up and continuing down the trail (*See Diagram on page 18*).

Diagram of Dozer 1 at Near Miss #1
