Informational Summary Report of Serious or Near Serious CAL FIRE Injuries, Illnesses and Accidents

GREEN SHEET

Burn Injuries

Thorne

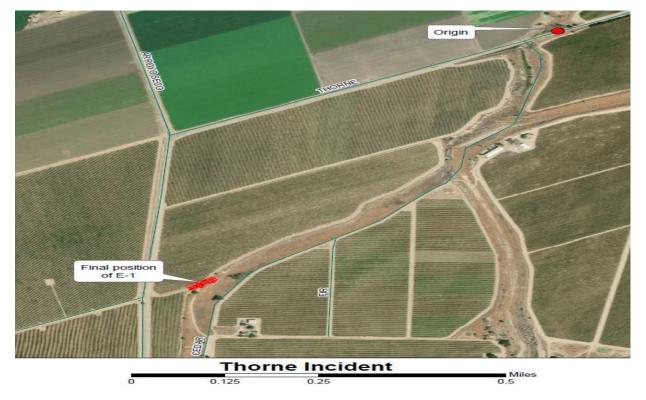
Picture 1 - Overview depicting the fire's origin to the burn over site, which was approx. ³/₄ of a mile.

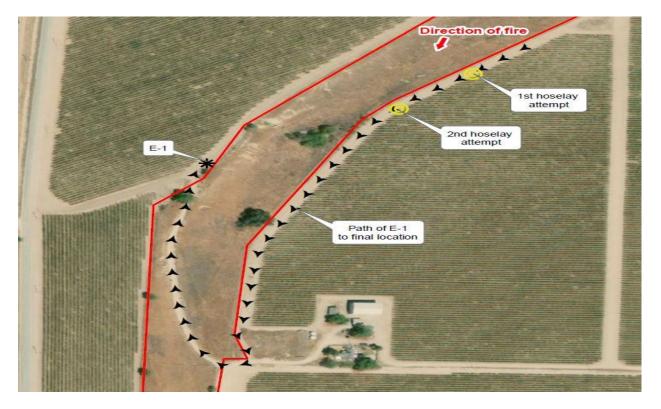
Picture 2 - E-1's travel path from the origin to the head of the fire where the firing operation occurred.

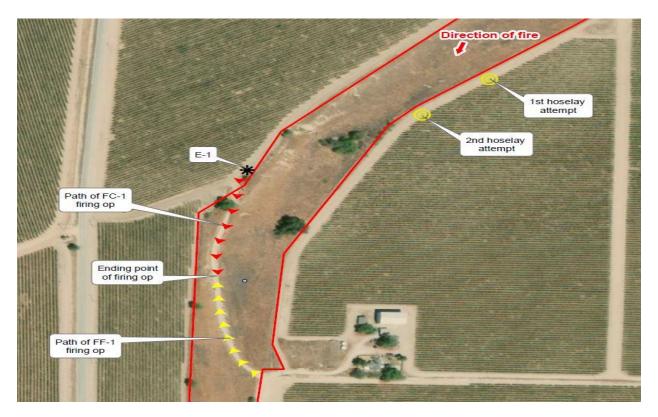
FC-1 repositioned the engine to the top of the cut-bank, dropping off a CAL FIRE Fire Fighter (FF-1) at the bottom of the mid-slope road, which was approximately 8 feet wide and 800 feet long. The firing operation was made below the mid-slope road extending from the lower dirt road to the upper dirt road (Picture #3). FF-1 was to start at the bottom while FC-1 & a CAL FIRE Fire Fighter (FF-3) started from the top. An additional CAL FIRE Fire Fighter (FF-2) made the decision to stay near the engine to pick up any spot fires. The plan was to take fire from the two furthest points and work toward each other, meeting in the middle. This was to build black line ahead of the fire, building depth against the dirt road. At about the time that FC-1, FF-3, & FF-1 completed the firing operation FC-1 directed FF-1 to create additional depth while returning to the bottom of the mid-slope dirt road. This was accomplished by dropping fusees below the initial blacked line. At that time a Thorne Incident Green Sheet Page **3** of **6**

Picture 3 - Depicting the firing operation and FC-1 & FF-1's starting & ending points.

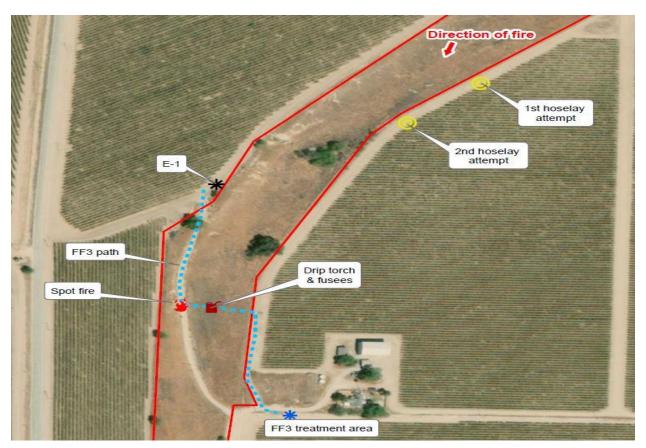
FF-3 witnessed a wall of flame in the direction of FC-1 and FF-2 and quickly looked downhill. Noticing a wall of flames in that direction as well, FF-3 made the decision to jump through the flames from the edge firing on the downhill side of the mid slope road toward an unburned island of the hillside. FF-3 threw the driptorch downhill and jumped, landing approximately 5 feet down the hillside. FF-3 tumbled and landed face first in an unburned area of the fire. FF-3 quickly stood up and proceeded toward the lower dirt road. Personnel from a Local Government Engine (E-2), located at the lower dirt road, witnessed FF-3 running down the hillside out of the smoke and fire. E-2 personnel and FF-1 quickly assessed FF-3, noticed burn injuries, and initiated treatment.

Picture 4 - FF-3's travel path from the ending point of the firing operation to the treatment area.
