# GREEN SHEET

### **Burn Over of Two Private Bulldozers – Firefighter Near Serious Accident**

**September 14, 2015**

**Lumpkin Incident**

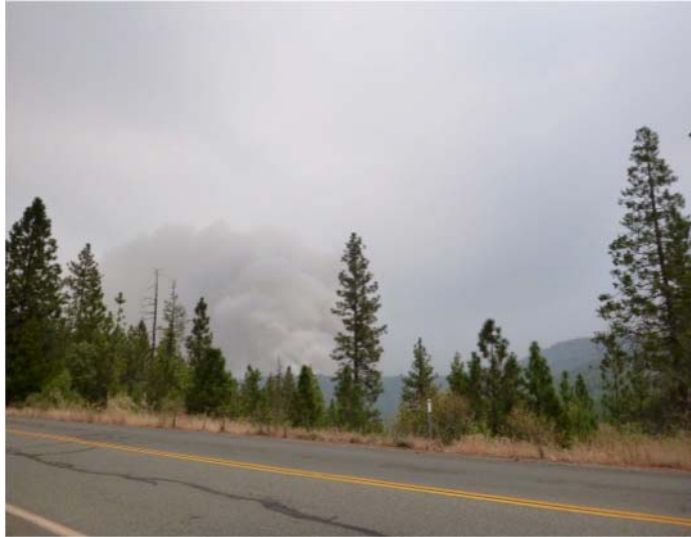
The fire progressed to a running crown fire and jumped Ponderosa Way.

This picture was taken,  
September 14, 2015, at 1204  
hours, shortly after fire crosses

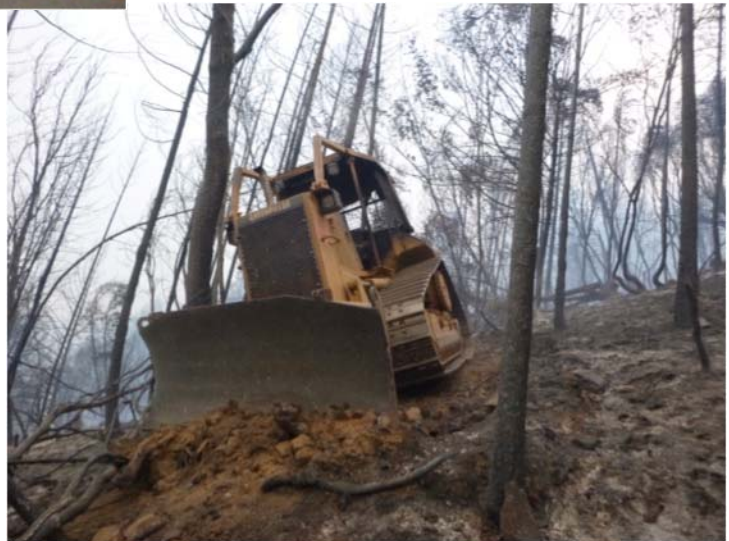
E-1 and E-6 sustained serious damage and were rendered inoperable.

This picture of E-1 was taken,  
September 14, 2015, at 1653 hours.

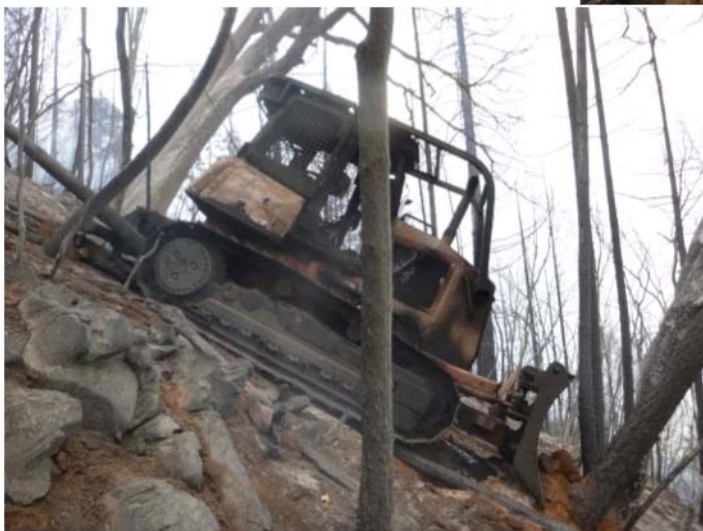
This picture of E-6 was taken,  
September 14, 2015, at 1703 hours.
