Informational Summary Report of Serious CAL FIRE Injuries, Illnesses, Accidents and Near-Miss Incidents

Partial Building Collapse with Injuries

November 11, 2011

GLEN SIDE

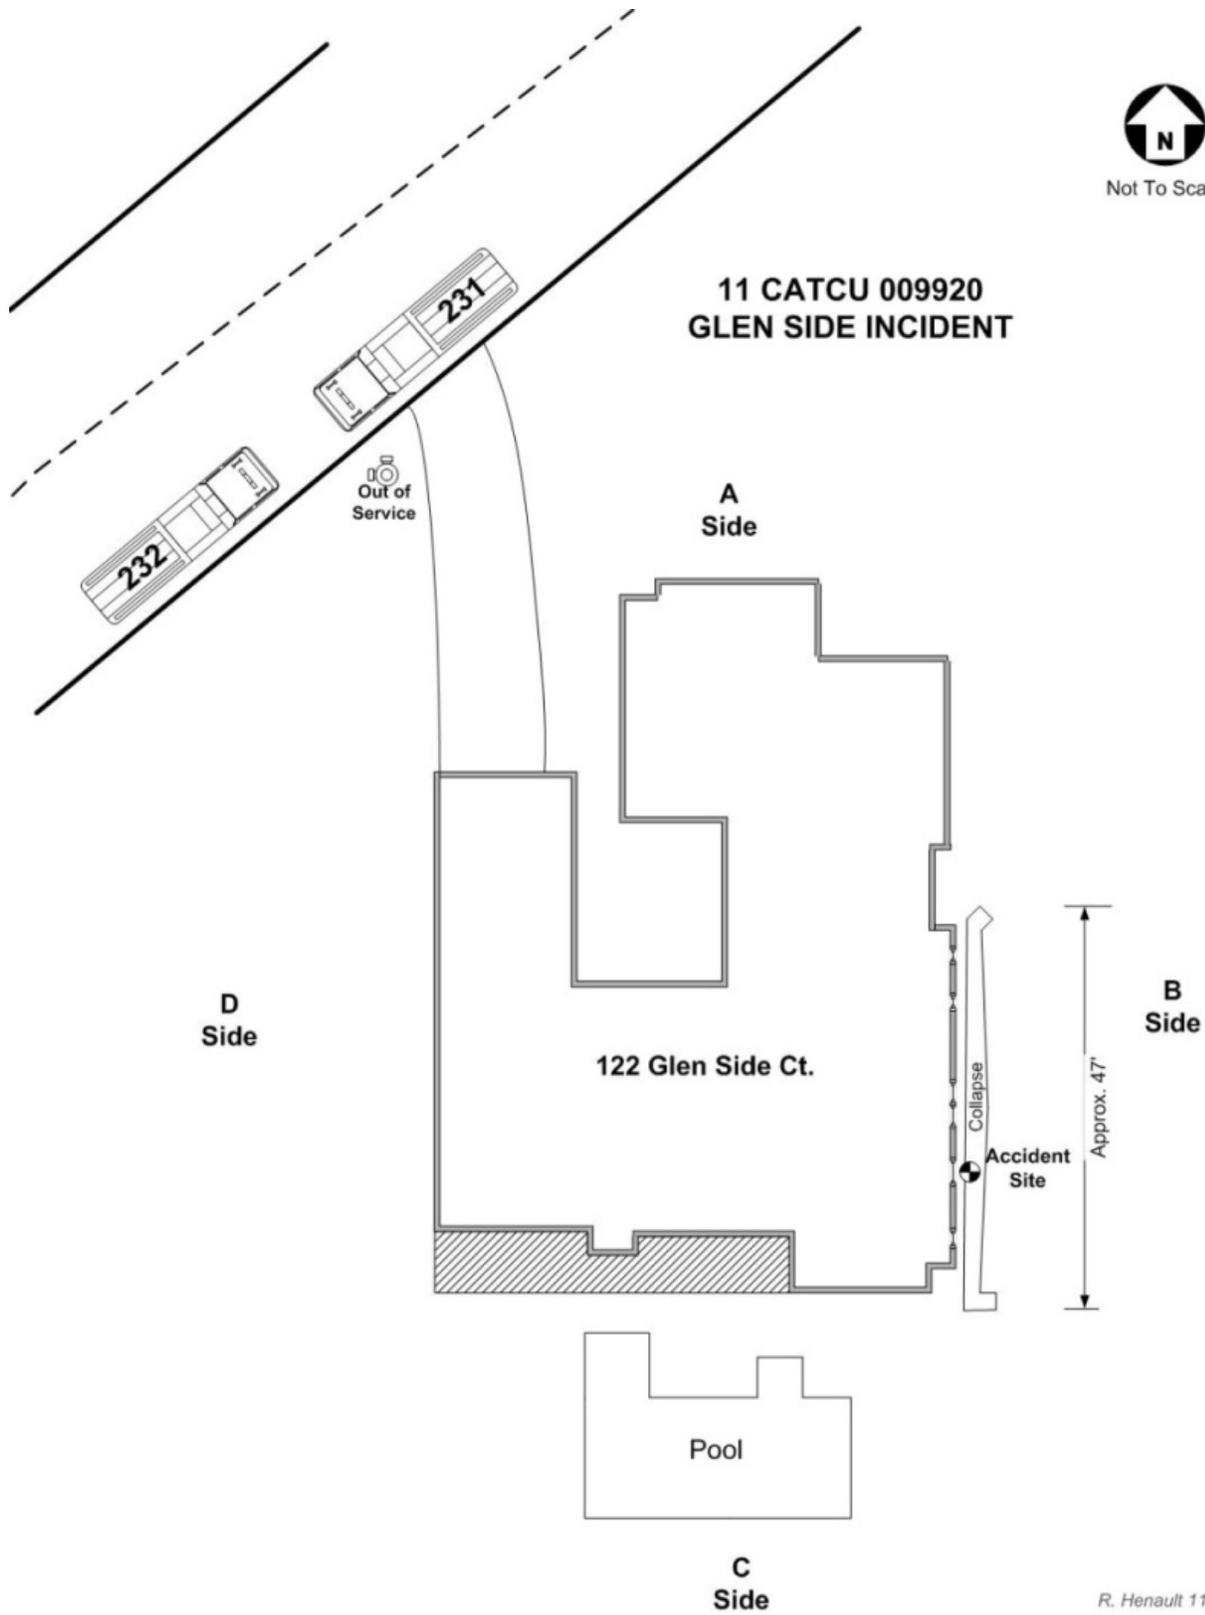
11 CATCU 009920 GLEN SIDE INCIDENT

The collapse is best described as the eave and gable end truss from the “B/C” corner forward to the “A/B” corner. The length of the collapsed section was approximately 47’ in length. The collapsed section also included the stucco covering of the gable end truss that hinged from the area of the top plate and remained partially attached. The initial indications are that as the gable end truss failed, it swung from the hinge point and struck the CAL FIRE Captain and the CFPD Firefighter, knocking them both to the ground.
