# GREEN SHEET

Informational Summary Report of Serious Injuries, Illness,  
Accidents and Near-Miss Incidents

Structure Fire  
Burn Injury

CA SAC #13084016

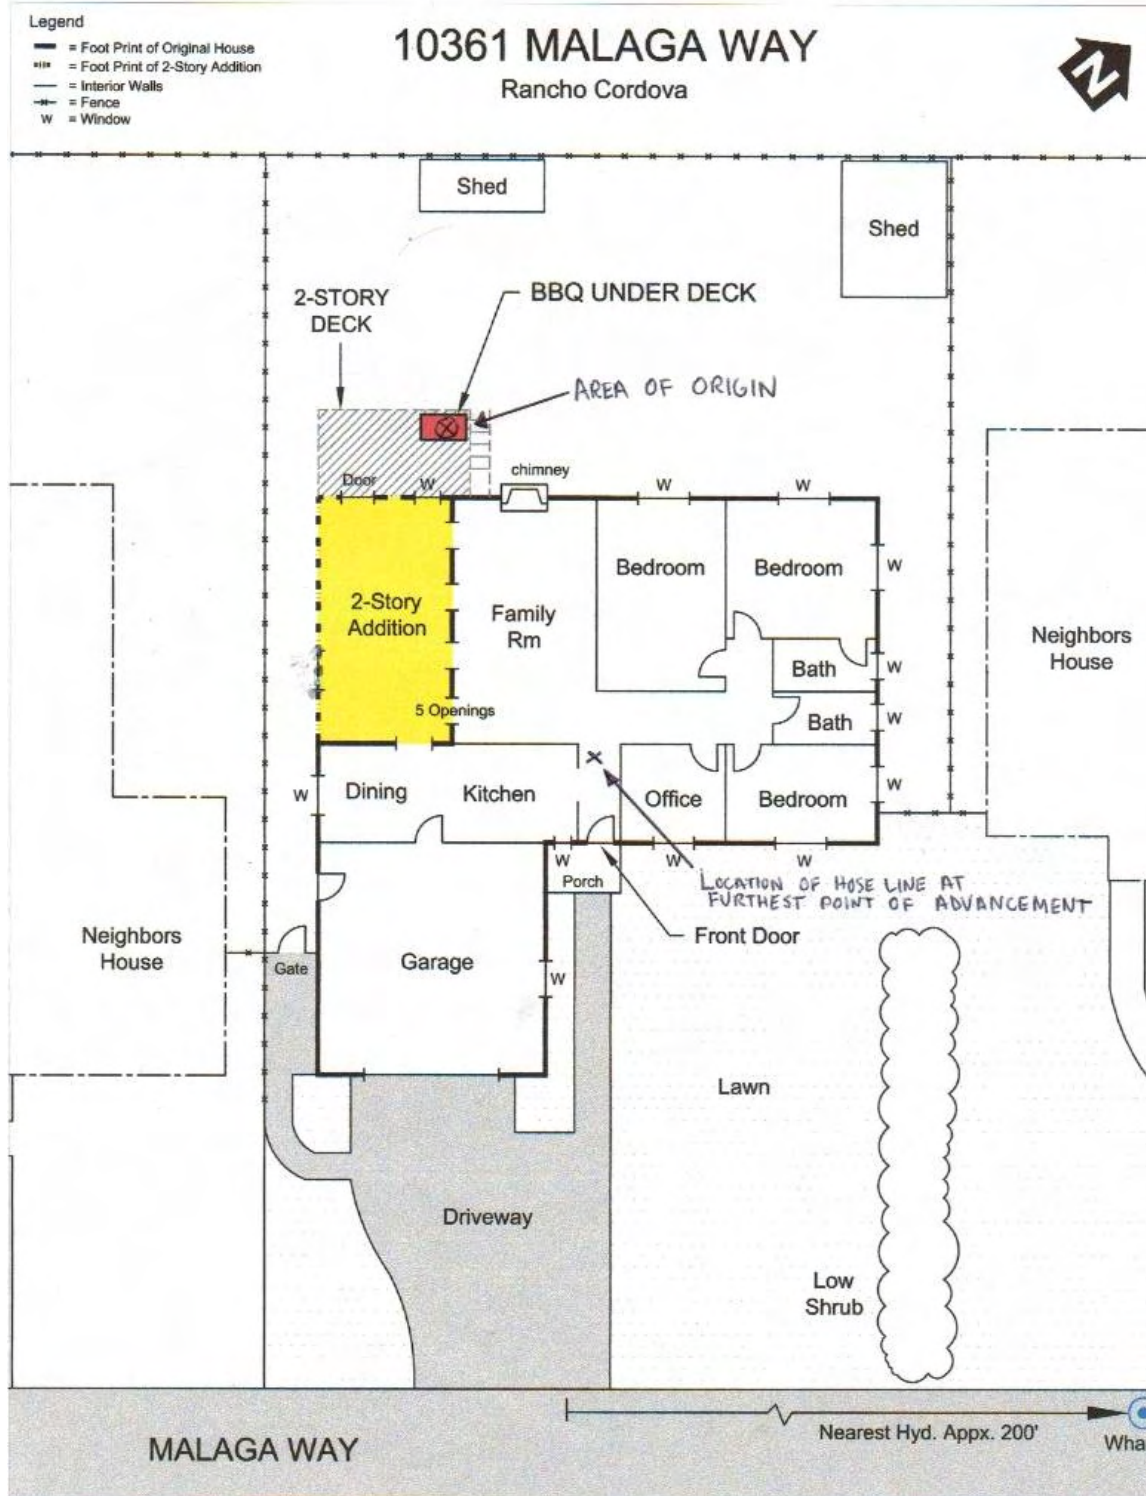
from the porch. M61 Control reported that he attempted to open the nozzle on the flames, but had great difficulty in seeing through his SCBA mask and directing the hose line at the fire. His mask was completely obscured due to heat damage.

M61 Control SCBA Facepiece
