Informational Summary Report of Serious or Near Serious CAL FIRE Injuries, Illnesses and Accidents

GREEN SHEET

Bulldozer Rollover Fatality

Ferguson Incident

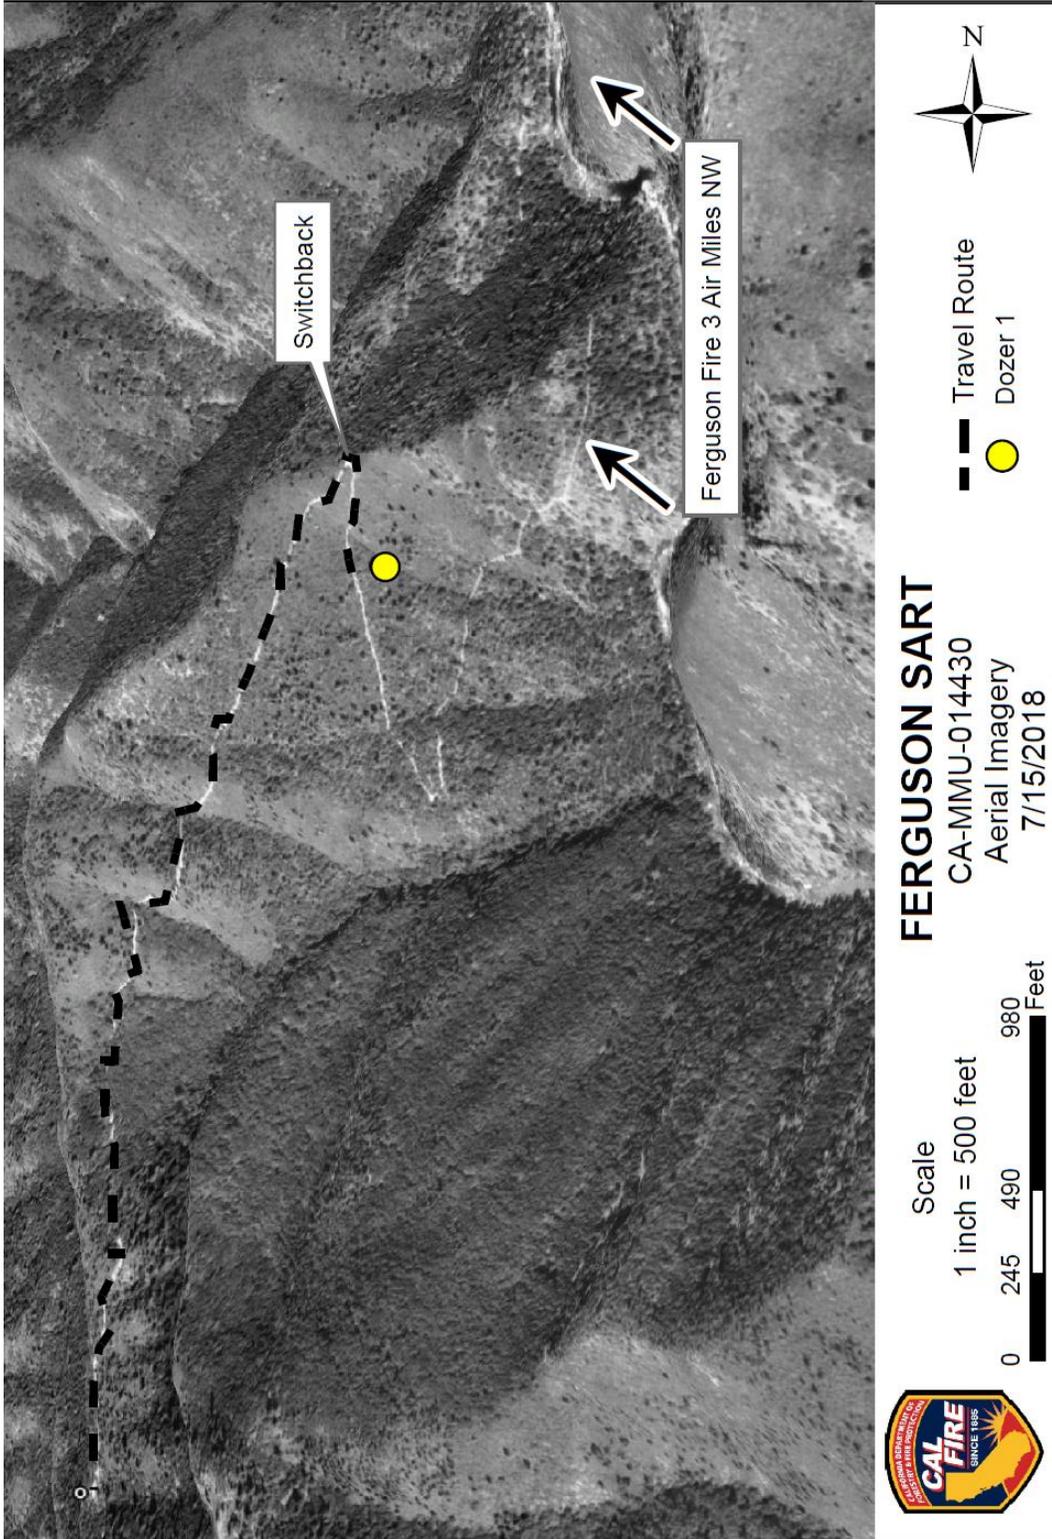
2012 John Deere 750J Crawler Dozer Medium with winch attachment and forestry package. The bulldozer is 18' 11" long, 8' 2" track width, 10' 8" blade width and weighs approximately 42,320 pounds.
